DAMASCUS ELEMENTARY SCHOOL FEASIBILITY STUDY

COMMUNITY MEETING 3 - VIRTUAL
MONTGOMERY COUNTY PUBLIC SCHOOLS

JUNE 25, 2025

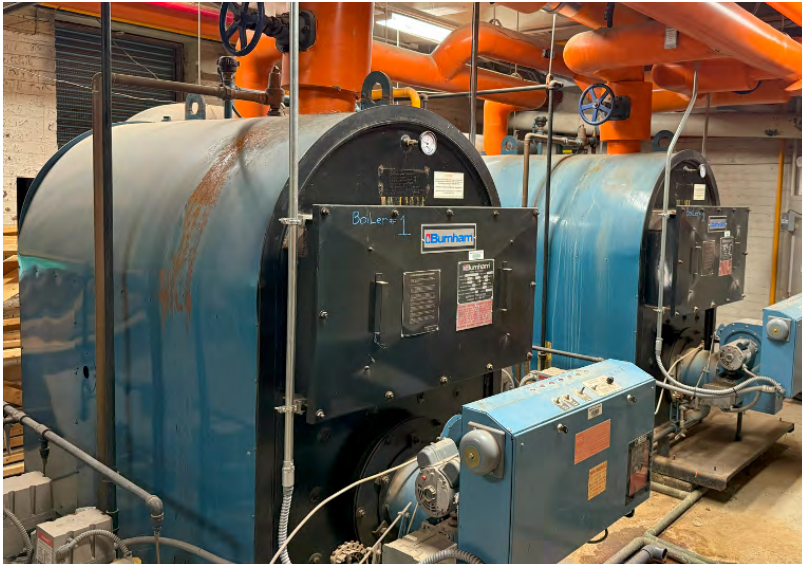
- Existing gas-fired boilers from 1988.
- Boilers do not comply with current codes and nearing end of useful service life.

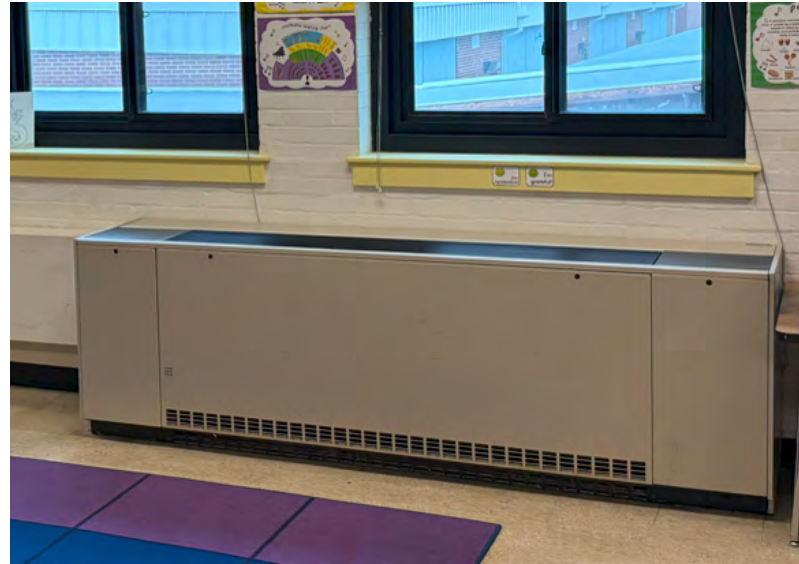
- Existing classroom unit ventilators installed in 2012. Heating water piping date back to 1979.
- Difficult for system to control humidity during humid outdoor conditions resulting in excessive cycling during off-peak conditions.

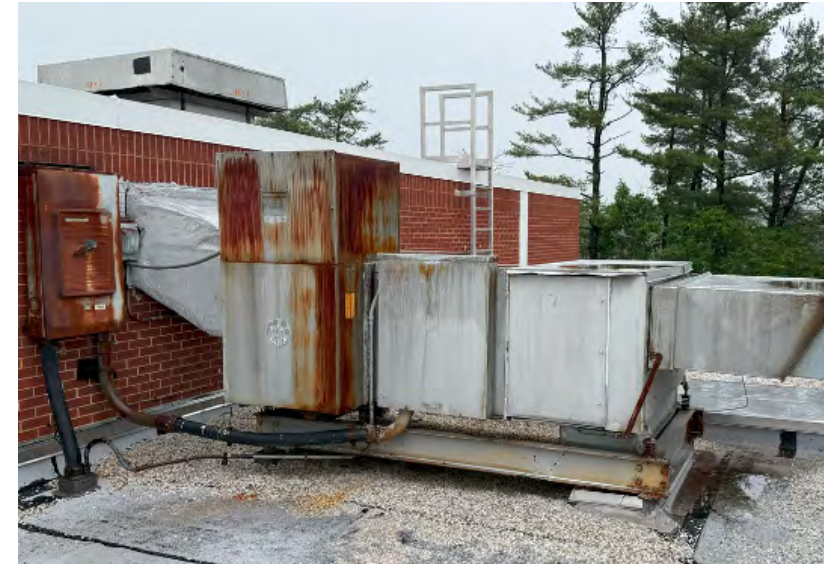
- Existing gym heating and ventilation unit, exact age of is unknown (est. 1975).
- Existing unit is in poor condition.
- No air-conditioning is currently provided.

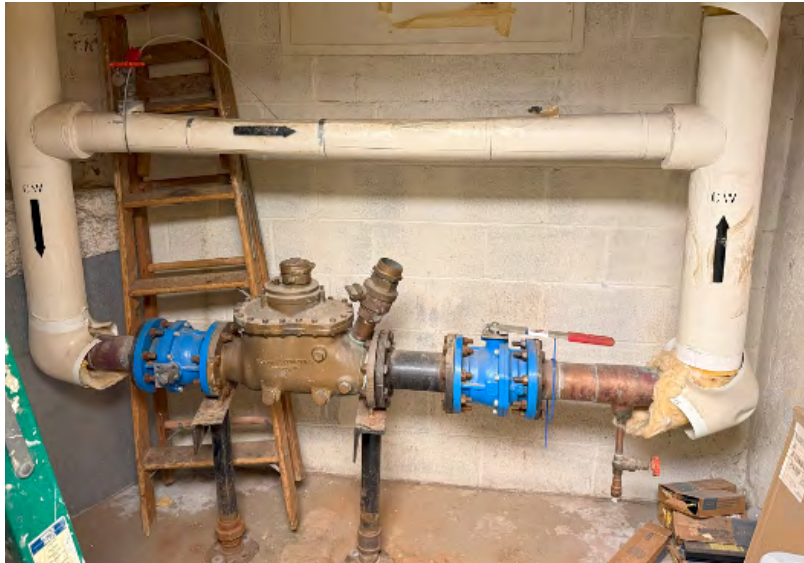
- Majority of domestic water piping installed in 1979.
- Piping system and components have exceeded their useful life.

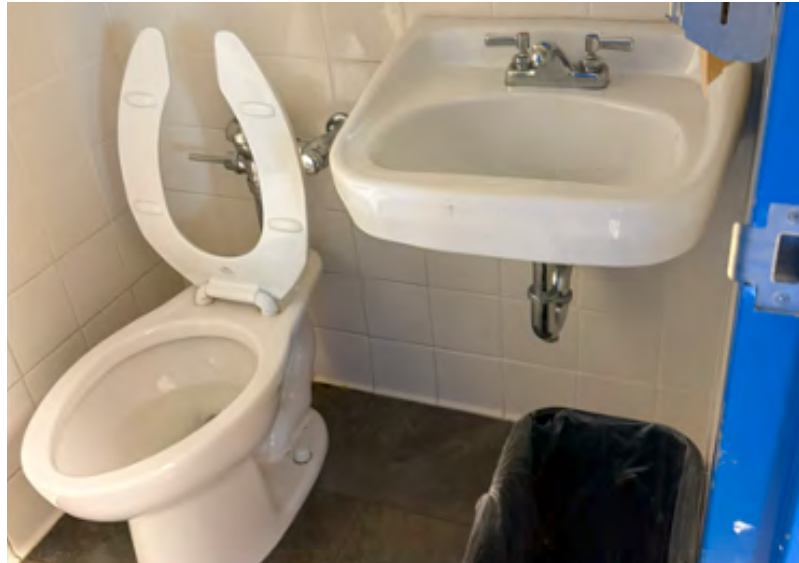
- Existing above and below-grade sanitary, waste, vent, and storm water piping are original to date of building area served.
- Ongoing issues noted by facilities team.
- Existing systems are beyond useful life.

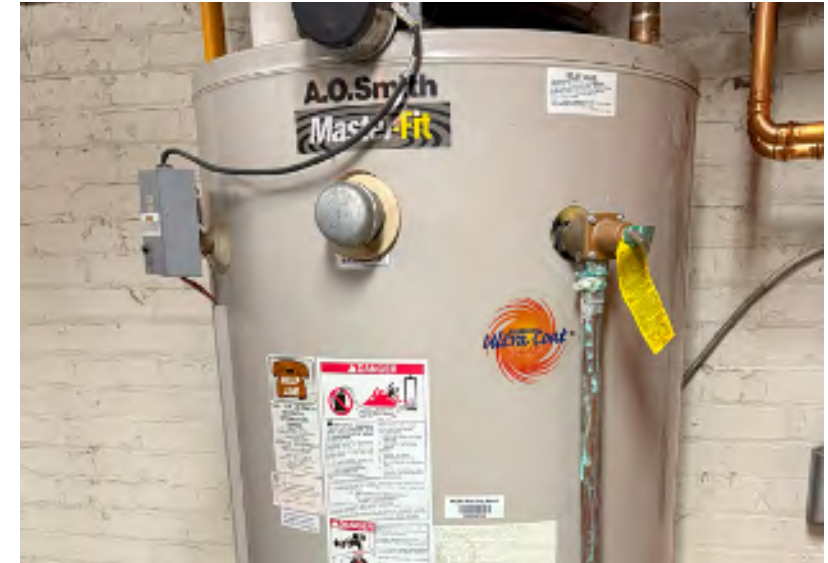
- Existing hot water heating in good to fair condition.
- Minimal surplus capacity exists for existing hot water heater.

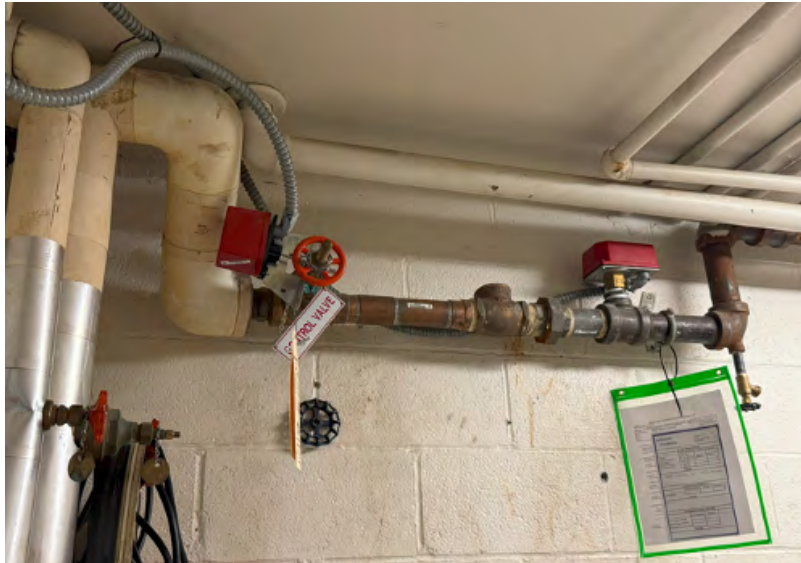
- Sprinkler coverage is limited, serves kitchen, multipurpose room & stage only.

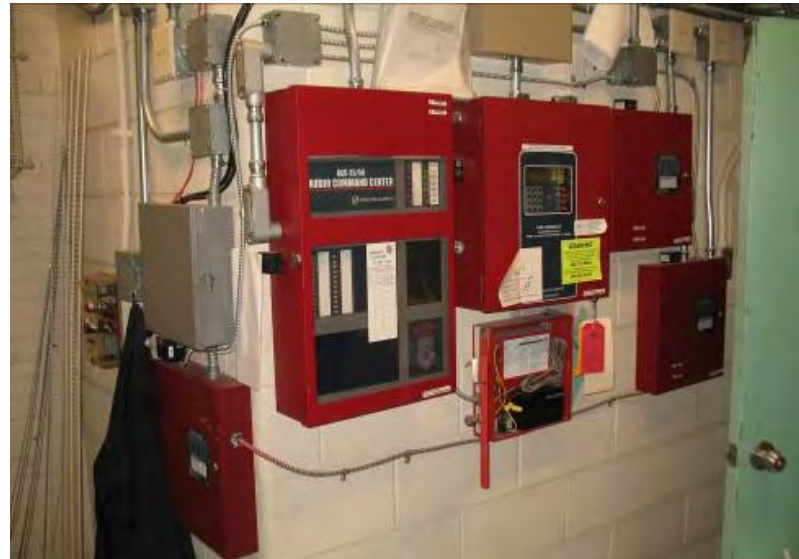
- Fire alarm equipment is located within the main electrical room.
- System includes voice evacuation alarm.

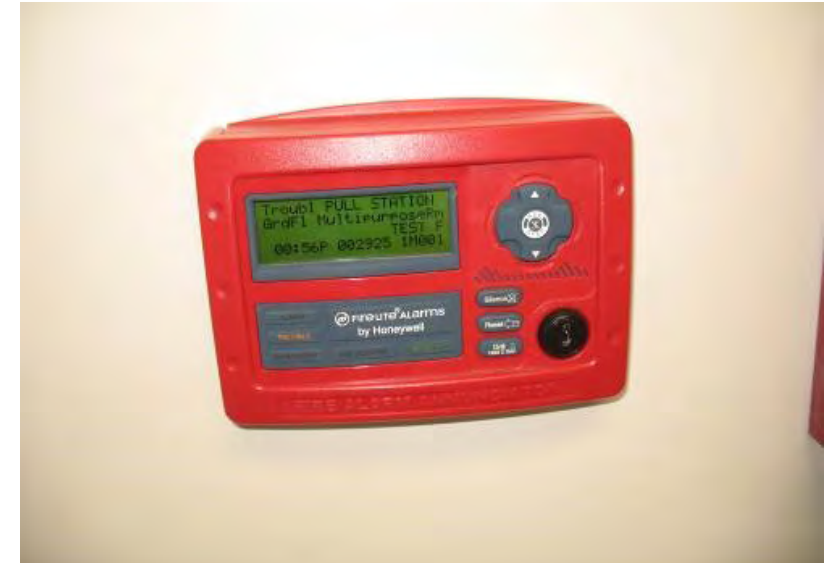
- Main entrance vestibule functions as the emergency command center with fire alarm annunciator display and emergency microphone.

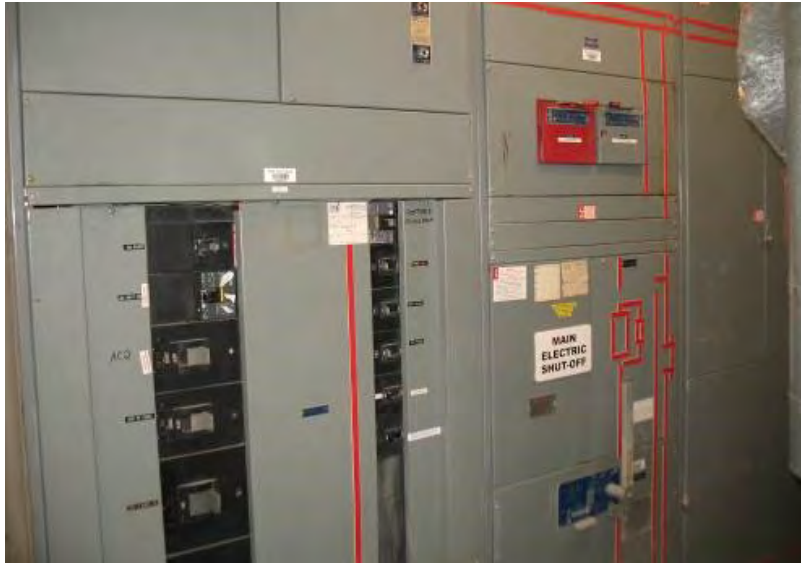
- Electrical equipment varies in age, majority of equipment is from 1979 renovation.
- Equipment from 1979-present is in fair to good condition.

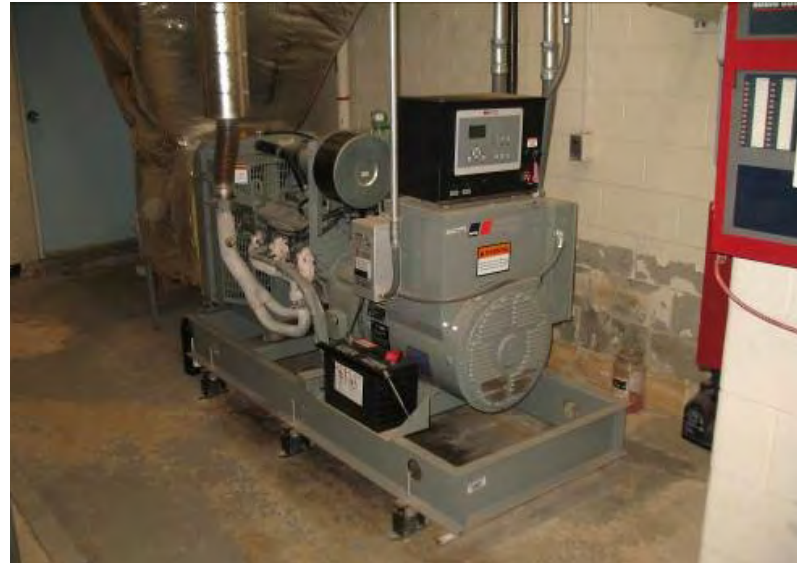
- Generator is from 2000.
- Equipment installed before 1979 is still being used, but is obsolete. Spare parts are no longer available for repairs.
- Ongoing issues noted by facilities team with older elec equipment.

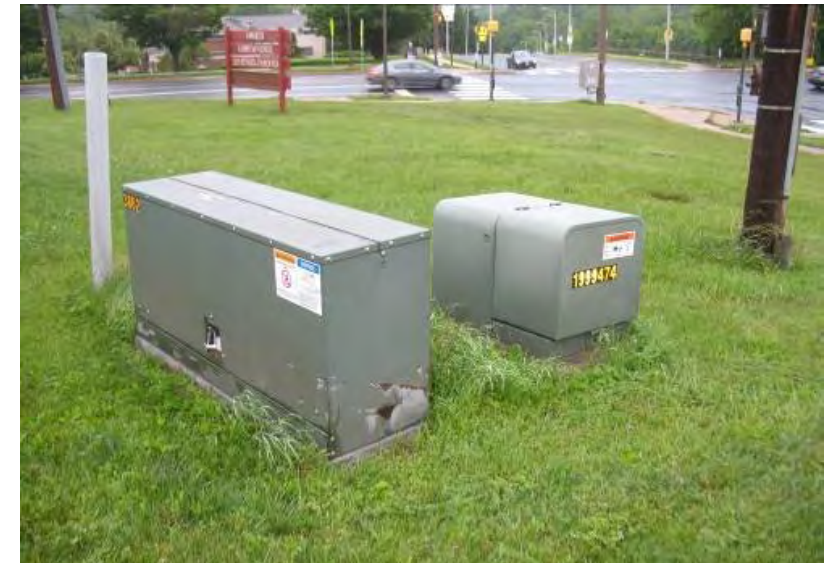
- Electrical service is by Pepco with the primary line located along the corner of Ridge & Bethesda Church Roads.
- Secondary transformers installed possibly to serve the relocatable classrooms.

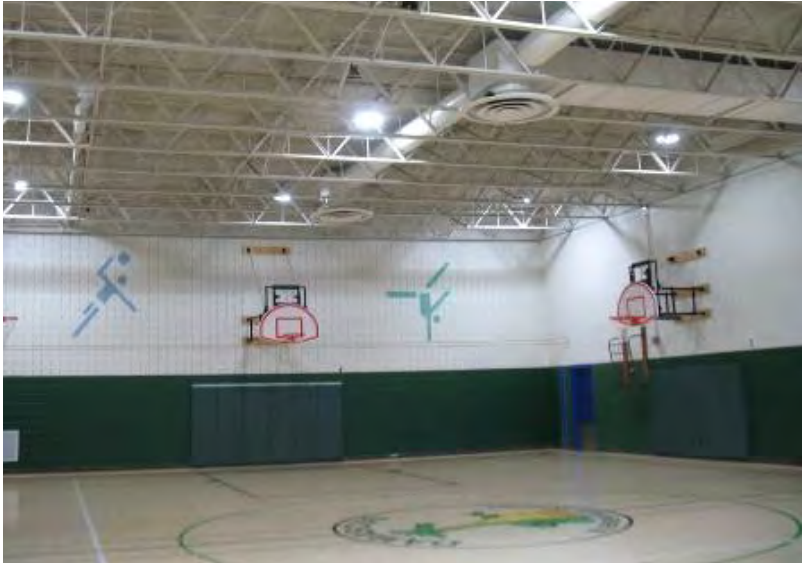
- LED lighting is installed in most classrooms and corridor spaces.
- Fluorescent lighting is used in back-of-house spaces.
- Gymnasium has LED high-bay UFO style light fixtures

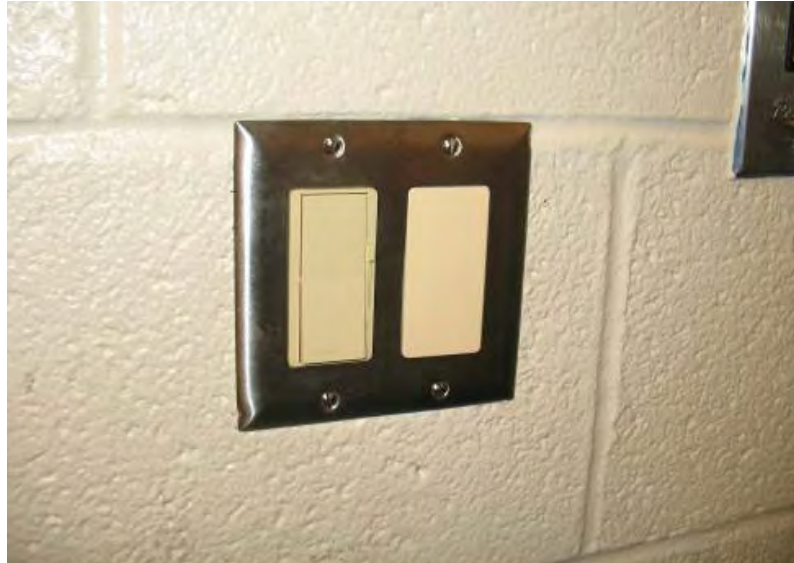
- Most classrooms do not have dimmable light switches.
- Admin Suite has dimmable light switches per current ed-spec.

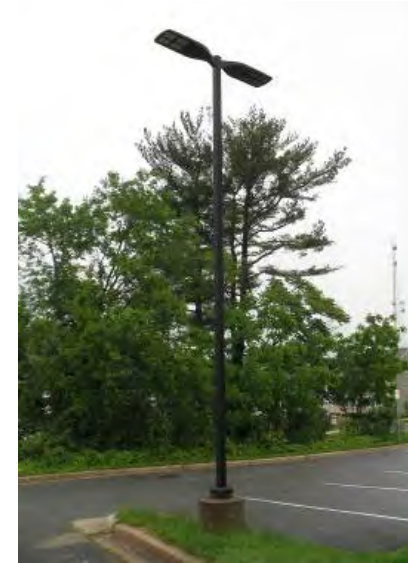
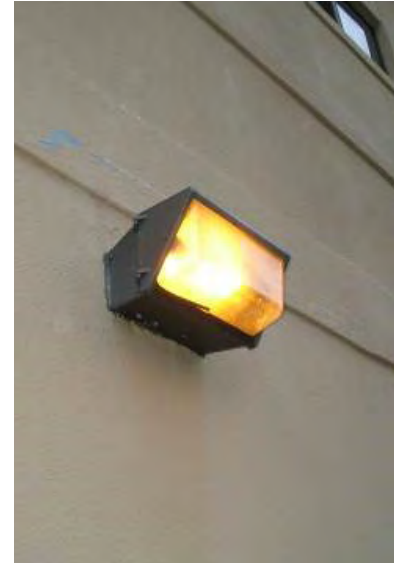
- Exterior lighting has pole-mounted LED light fixtures or building mounted wall packs with high-intensity discharge lamps.

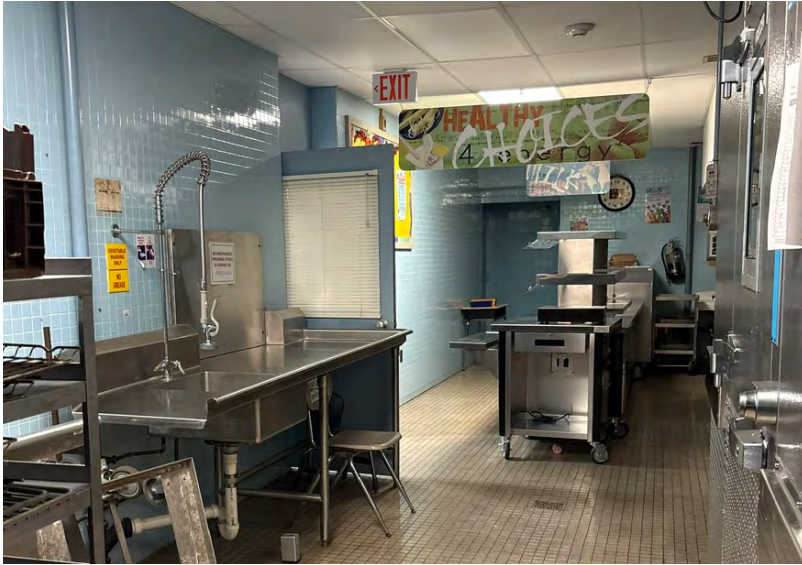
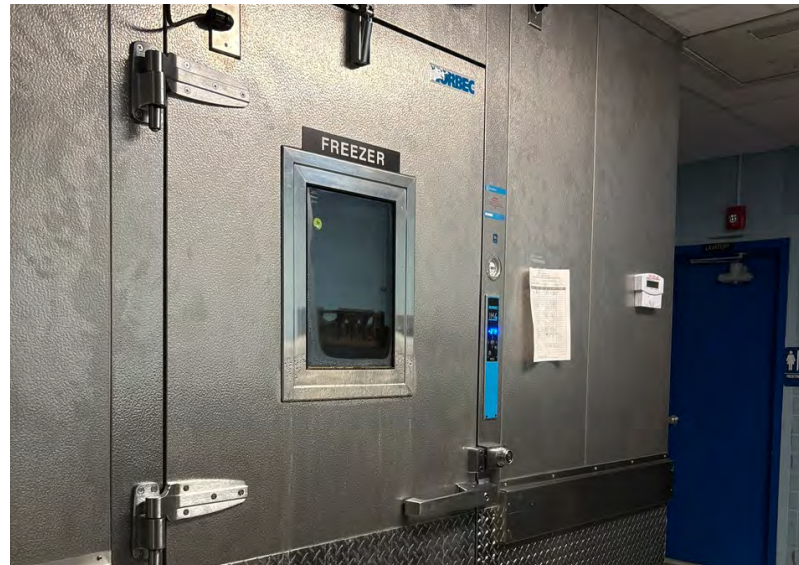
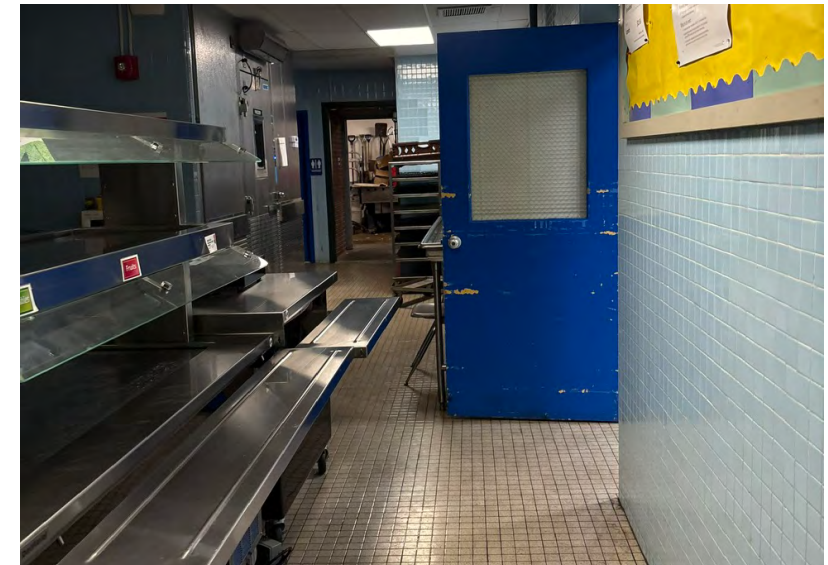
- Kitchen does not have air conditioning and is served by heating only.
- Kitchen has sprinkler line for fire suppression.
- Equipment within kitchen appear to be in good condition.
- Kitchen is missing office space & locker room area for staff.
- Restroom serving kitchen is not ADA compliant.
- Kitchen serving line starts within school corridor and ends within Multipurpose room.

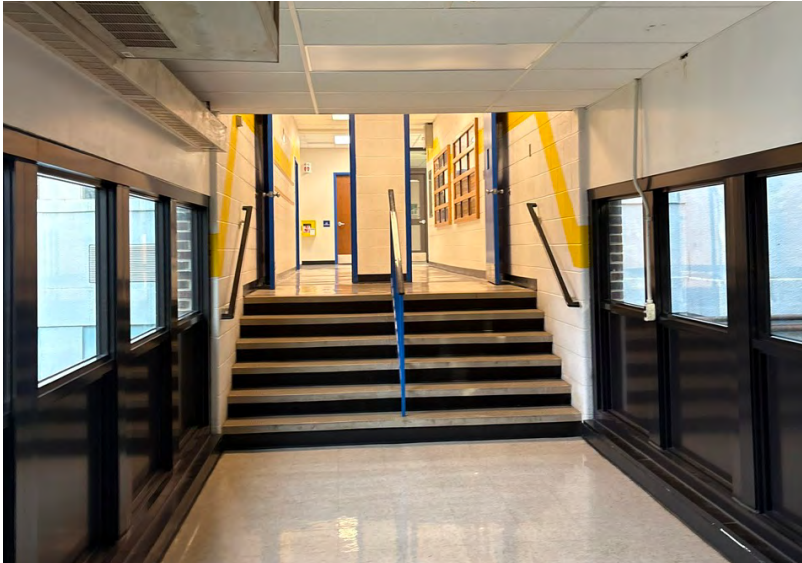
- Existing building has five occupied levels, connected via stairs and ramps.
- Existing ramps are not ADA compliant.
- Elevator is located in remote area at administration suite.

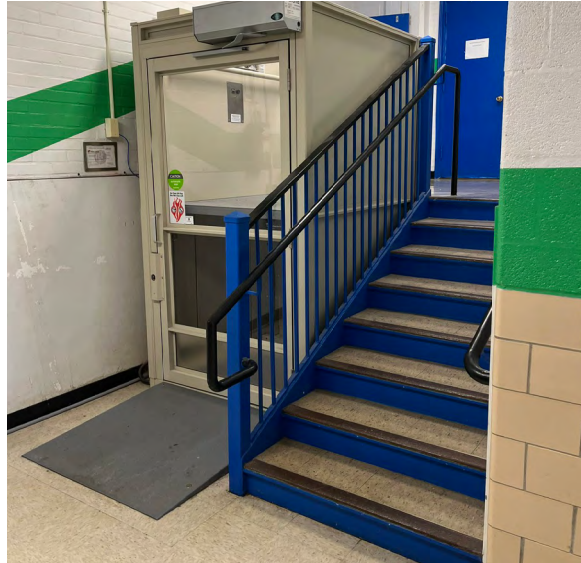
- Chairlift by Library Media Center was replaced in 2021.
- Exterior site improvements were made in 2019 to sidewalks and ramps, however site is lacking accessible routes to softball field, ADA parking to building.

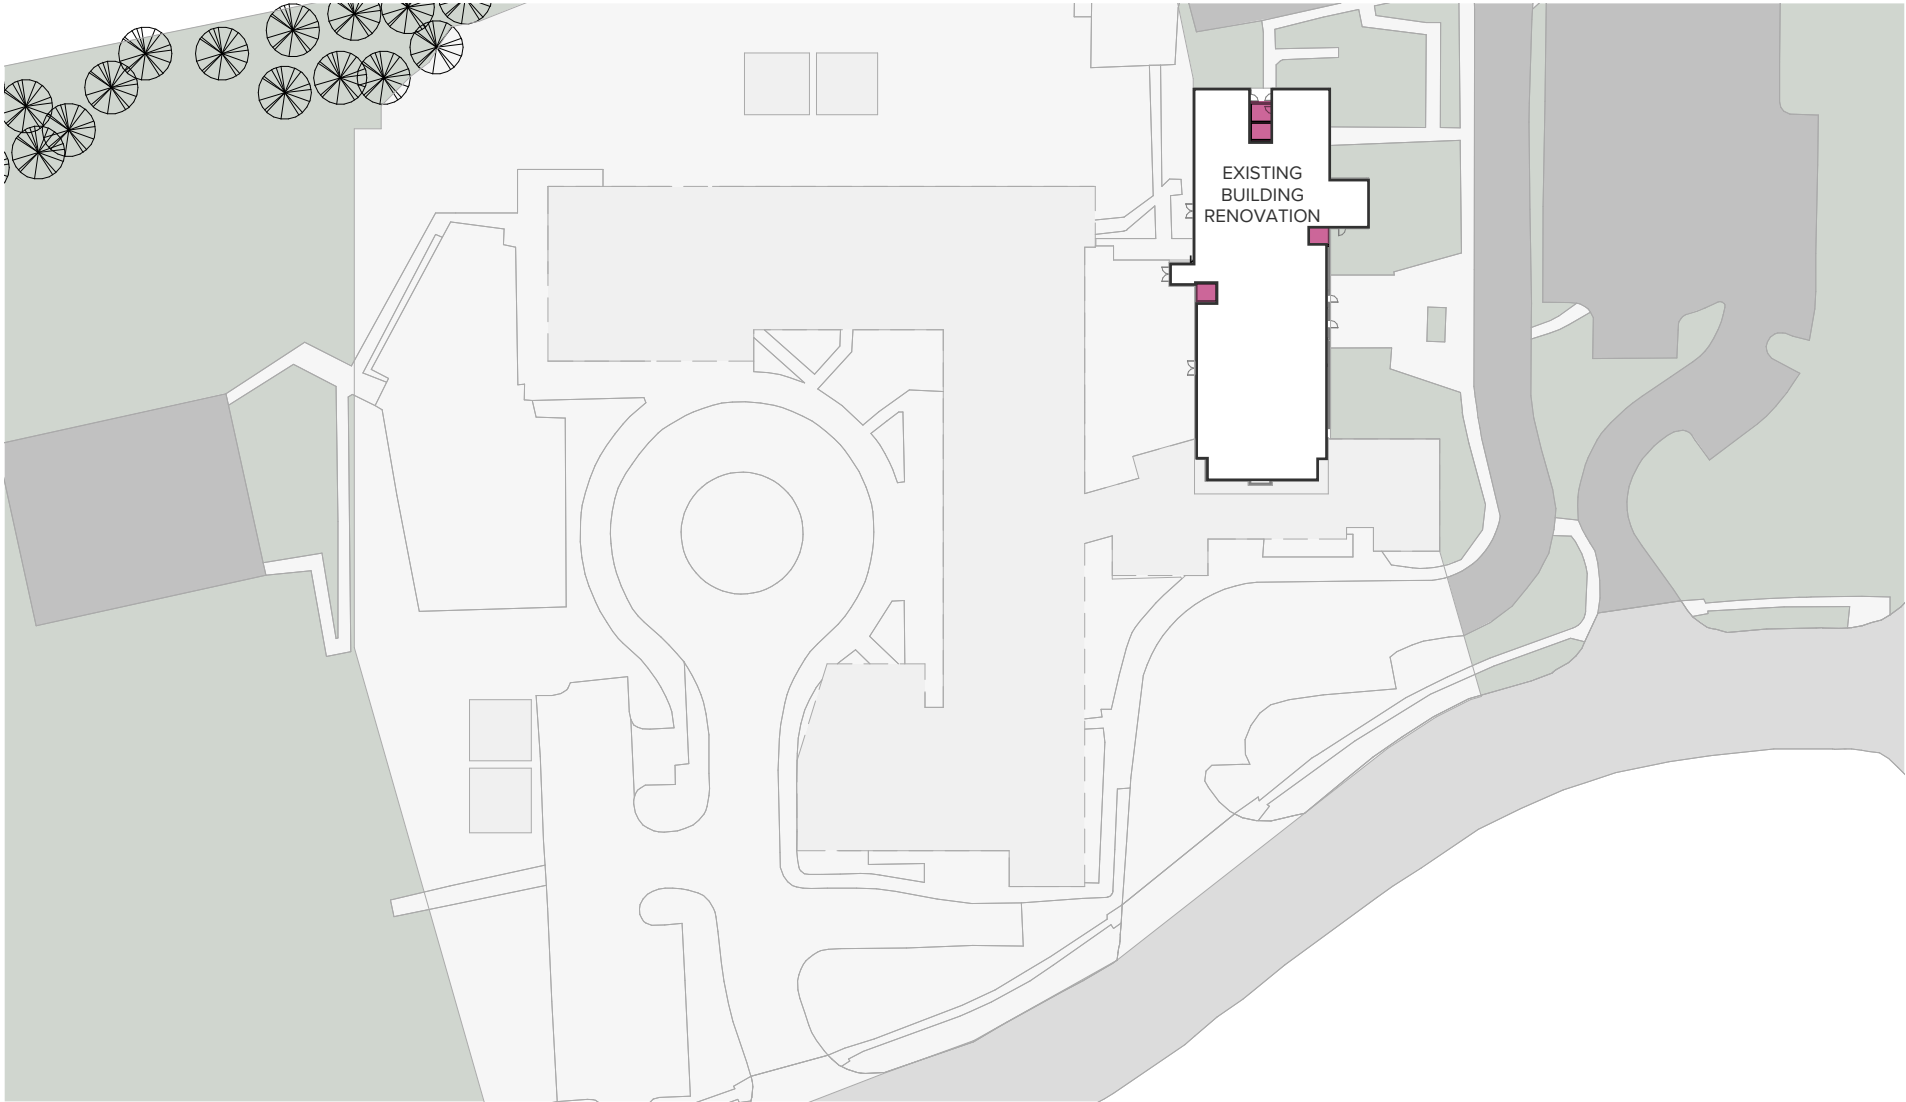
OPTION 1 - RENEWAL

- ENTRY
- EXISTING BUILDING / RENEWAL
- BUILDING ADDITION
- ACCESSIBILITY / TOILET ROOM UPGRADES / INTERIOR RECONFIGURATION

Option 1 - Renewal
SCOPE	<ul style="list-style-type: none">• Replace Mechanical, Electrical, & Plumbing system in existing building• Renovate finishes in existing building• Upgrade existing restrooms to meet MCPS standards• Renovate existing building to meet accessibility standards.• Existing parking and play areas remain unchanged <p>50,533 SF - Renewal 6,593 SF - Renovation</p>
PROS	<ul style="list-style-type: none">• Sprinkler system added• Replaces outdated building systems• More efficient building systems for HVAC• Cost effective
CONS	<ul style="list-style-type: none">• Design does not meet ed spec• Relocatable classrooms stay on site• Less flexibility for growth• Bus loop & student drop off are not co-located

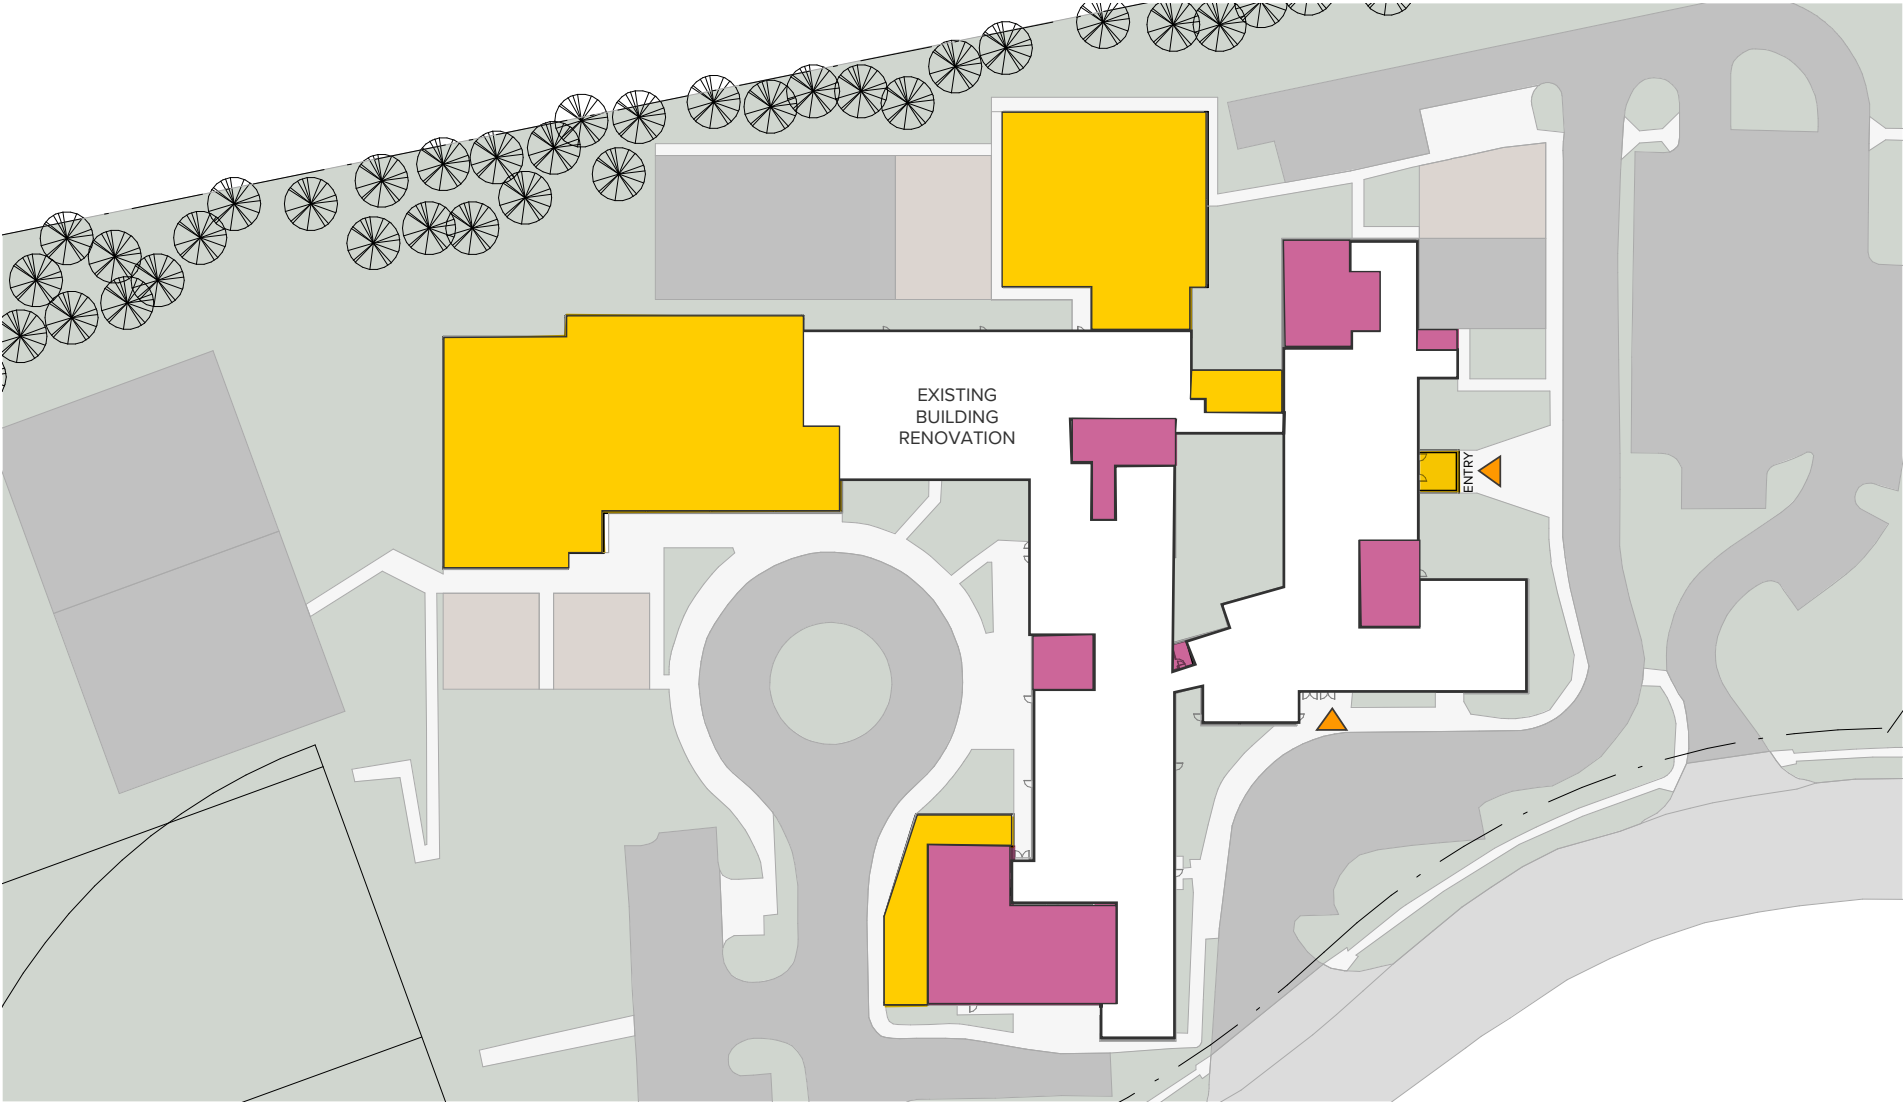
OPTION 2 - LESS THAN 50% DEMO

- ENTRY
- EXISTING BUILDING / RENEWAL
- BUILDING ADDITION
- ACCESSIBILITY / TOILET ROOM UPGRADES / INTERIOR RECONFIGURATION
- MECHANICAL/ELECTRICAL/PLUMBING ROOM LOWER LEVEL

Option 2 - Less than 50% Demo
SCOPE	<ul style="list-style-type: none">• Less than 50% of existing building would be demolished and additions would be added to meet program requirements.• Replace Mechanical, Electrical, & Plumbing system in existing building• Renovate finishes in existing building• Upgrade existing restrooms to meet MCPS standards• Renovate existing building to meet accessibility standards. <p>10,017 SF - Renovation 41,337 SF - Renewal 5,792 SF - Demolition 24,221 SF - New Construction</p>
PROS	<ul style="list-style-type: none">• Sprinkler system added• Replaces outdated building systems• More efficient HVAC• Addresses accessibility issues within buildings• Design meets ed spec for size of rooms & outdoor play spaces
CONS	<ul style="list-style-type: none">• Inefficiencies in existing building to address accessibility and new restroom layout• Does not meet all room adjacency requirements within existing building.• Bus loop & student drop off are not co-located

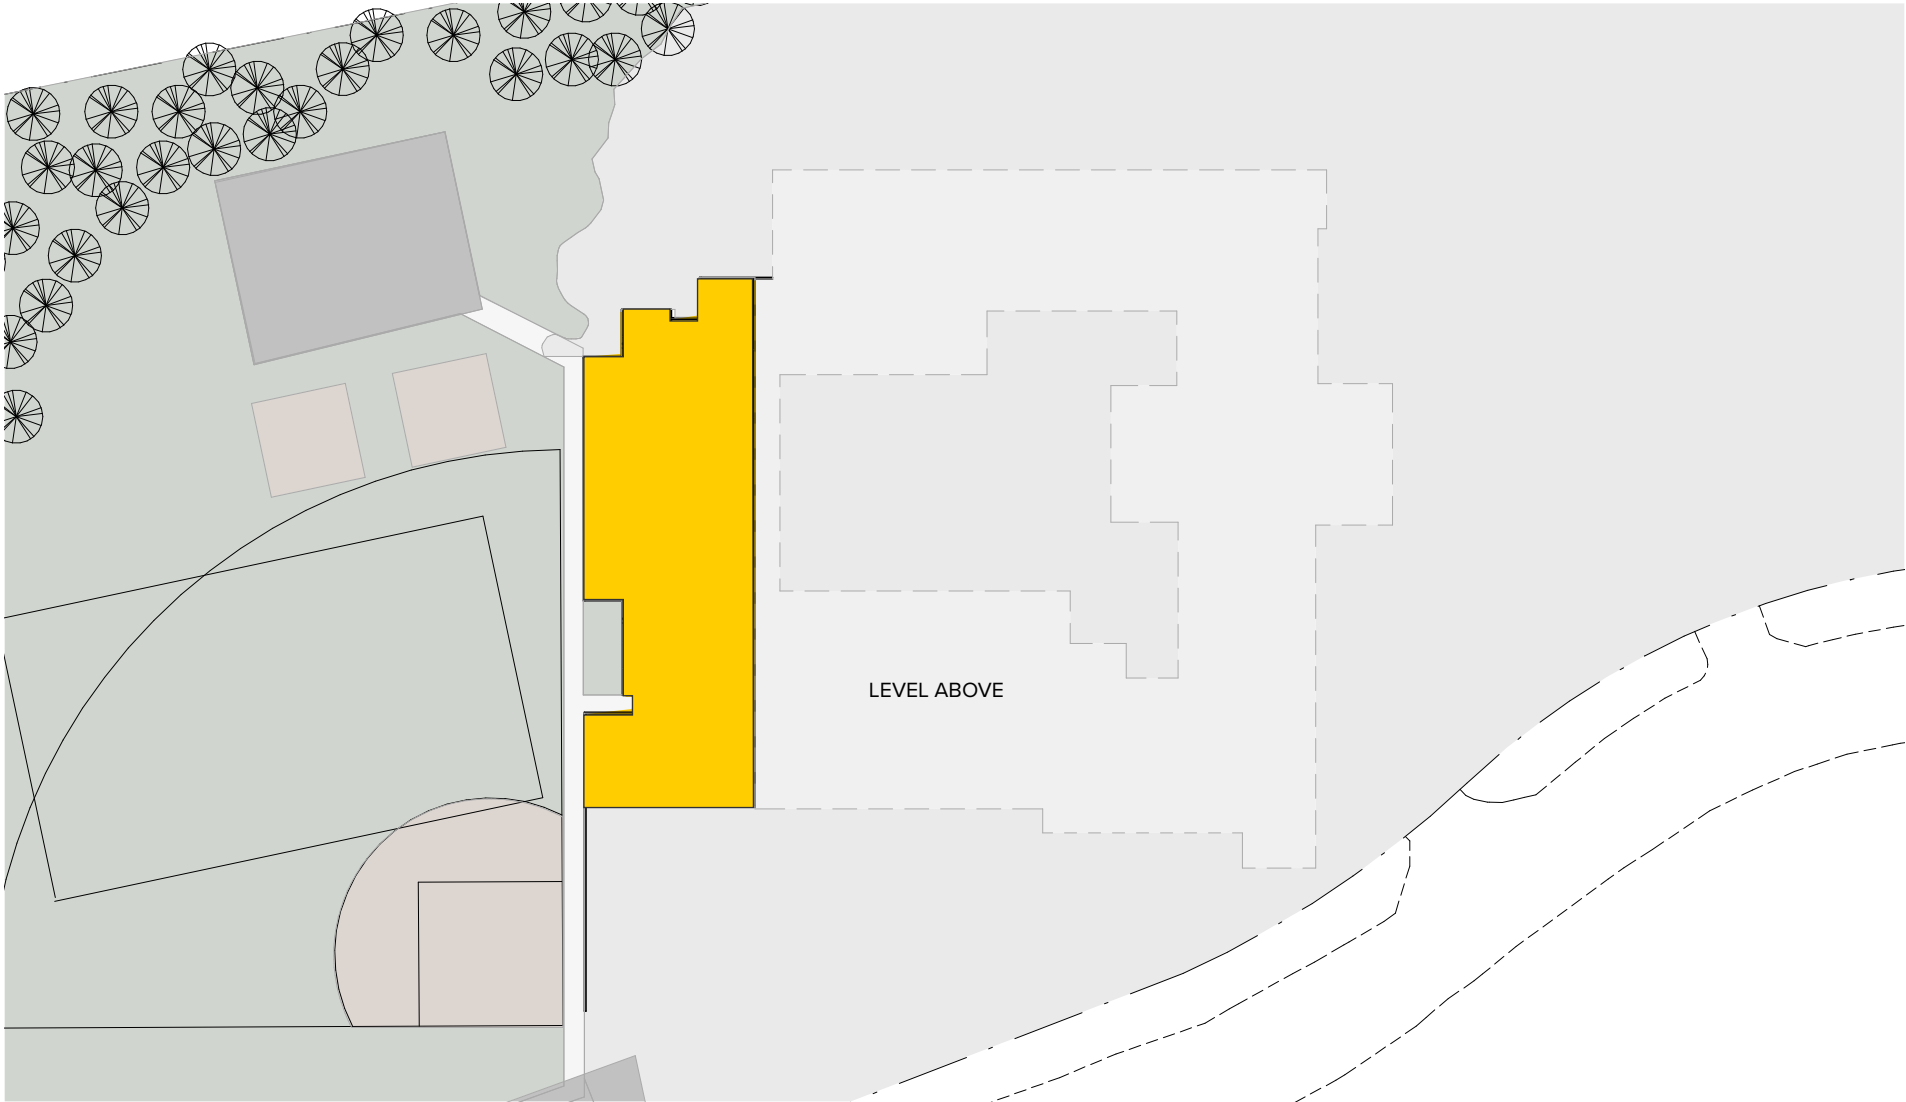
OPTION 3 - MORE THAN 50% DEMO

- ENTRY
- EXISTING BUILDING / RENEWAL
- BUILDING ADDITION
- ACCESSIBILITY / TOILET ROOM UPGRADES / INTERIOR RECONFIGURATION

Option 3 - More than 50% Demo
SCOPE	<ul style="list-style-type: none">• More than 50% of existing building would be demolished and additions would be added to meet program requirements.• Replace Mechanical, Electrical, & Plumbing system in existing building• Renovate finishes in existing building• Upgrade existing restrooms to meet MCPS standards• Renovate existing building to meet accessibility standards. <p>23,365 SF - Renewal 5,749 SF - Renovation 28,032 SF - Demolition 44,528 SF - New Construction</p>
PROS	<ul style="list-style-type: none">• Sprinkler system added• Replaces outdated building systems• More efficient HVAC• Addresses accessibility issues within building and site.• Design meets ed spec for room sizes• Single accessible entrance for all students• Separate circulation paths for cars, buses and service
CONS	<ul style="list-style-type: none">• Inefficiencies in existing building to address accessibility and new restroom layout• Does not meet all room adjacency requirements within existing building
