AGENDA

FEASIBILITY STIINY

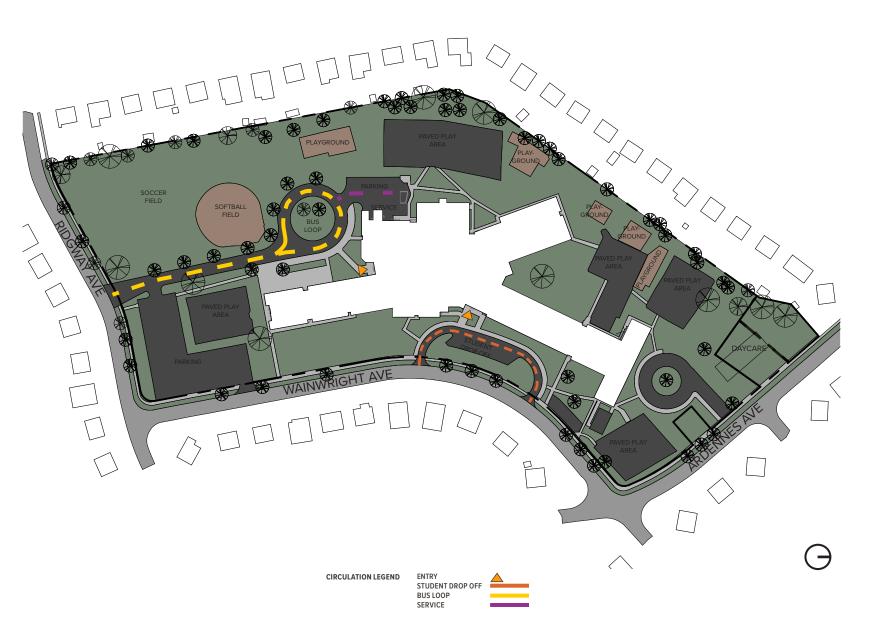
OPTION 1 - RENEWAL SUMMARY

Option 1 -Renewal SUMMARY 70,750 GSF - Renewal 7,948 GSF - Renovation AREA 69% - Gross Efficiency **Building Renovation New Elevator** Electrical & Plumbing system replacement Renovate finishes SCOPE Gender Neutral Restroom upgrade Accessibility Standard renovations for site and building Maintain location of play areas and fields Maintain location of parking, car and bus drop offs.

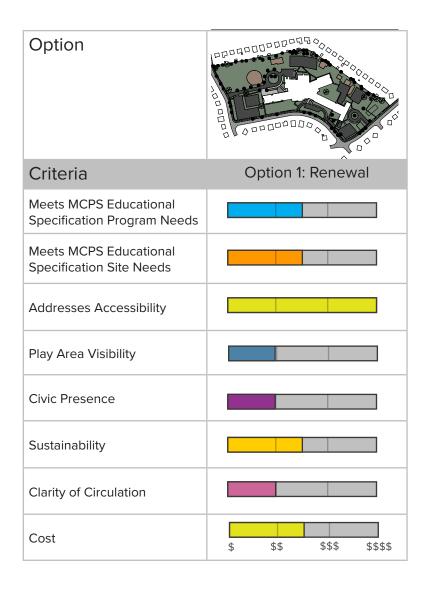
OPTION 1 - RENEWAL

70,750 GSF - Renewal 7,948 GSF - Renovation 69% - Gross Efficiency

- Sprinkler system added
- New building systems
- Addresses accessibility issues
- Community-sized gym remains
- Cost effective
- Sustainable finish building materials
- Shortest Construction Schedule
- Compartmentalization added with new firewalls

- Cannot accommodate program spaces:
 Dual-Purpose Room, Music, Instrumental Music, Kitchen support spaces.
- Rooms undersized: Administration, Health Services, 5 Classrooms, Multi-Purpose Room, & Kitchen
- No lockers in corridors
- Low visibility to playgrounds
- Low visibility to main entrance
- Does not address safety concerns at Daycare drop off
- Type V-B Construction remains

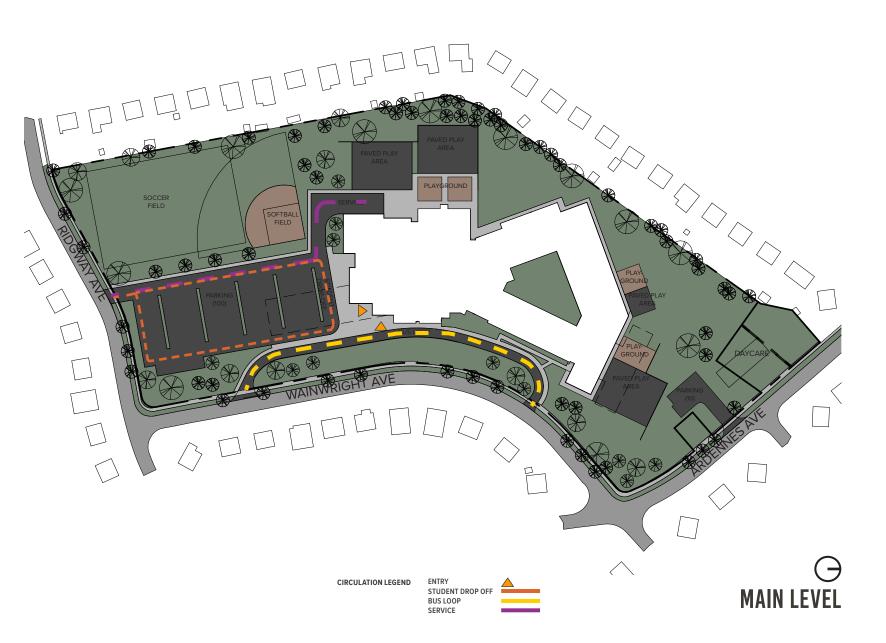
OPTION 2 - LESS THAN 50% DEMO - SUMMARY

Option 2 -Less than 50% Demo

30,913 GSF - Demolition 36,645 GSF - Renewal 12,192 GSF - Renovation 29,772 GSF - Addition 72% - Efficiency

- Building Additions added to meet program requirements.
- Electrical & Plumbing system replacement
- Renovate finishes

- Restroom upgrade
- Accessibility Standard renovations
- · Maintain location of fields
- New location for parking, car and bus drop offs
- New location for play areas

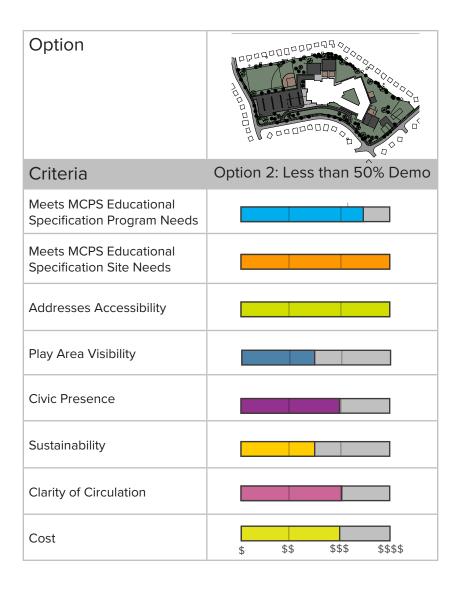
OPTION 2 - LESS THAN 50% DEMO

30,913 GSF - Demolition 36,645 GSF - Renewal 12,192 GSF - Renovation 29,772 GSF - Addition

- Sprinkler system added
- Replaces outdated building systems
- Addresses accessibility issues
- Design meets ed spec
- Community-sized gym
- Compartmentalization added with new firewalls
- Sustainable finish building materials.
- New Daycare drop off
- 1-Story building

- Lockers cannot fit in existing corridors
- Low visibility to playgrounds
- Type V-B Construction remains
- No daylight in Media Center & Resource Rooms.

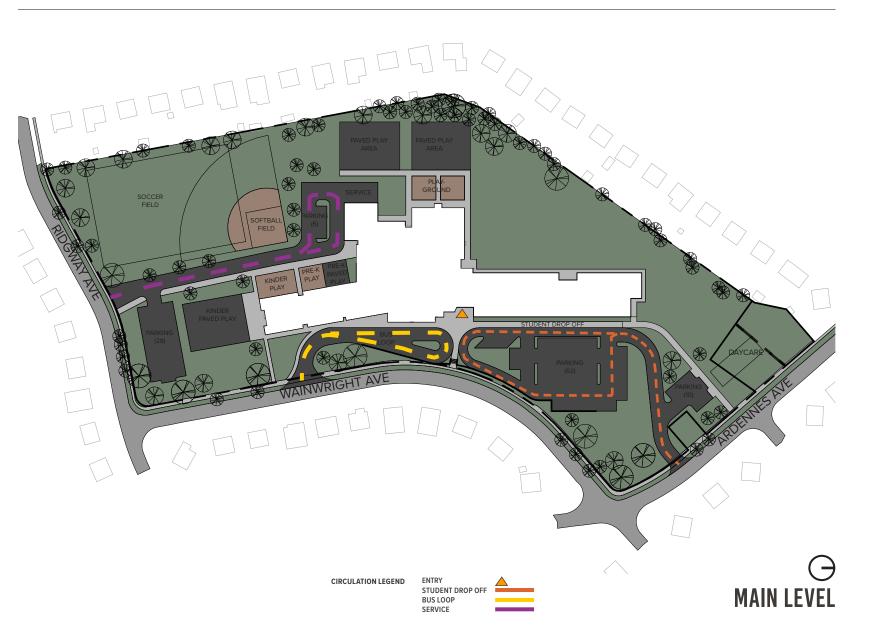
OPTION 3 - MORE THAN 50% DEMO - SUMMARY

Option 3 -More than 50% Demo

40,813 GSF - Demolition 28,971 GSF - Renewal 9,966 GSF - Renovation 41,568 GSF - Addition 71% - Efficiency

- New Building Additions
- Electrical & Plumbing system replacement
- · Renovate finishes

- Gender Neutral Restroom upgrade
- Accessibility Standard renovations
- · Maintain location of fields
- New location for parking, car and bus drop offs
- New locations for play areas

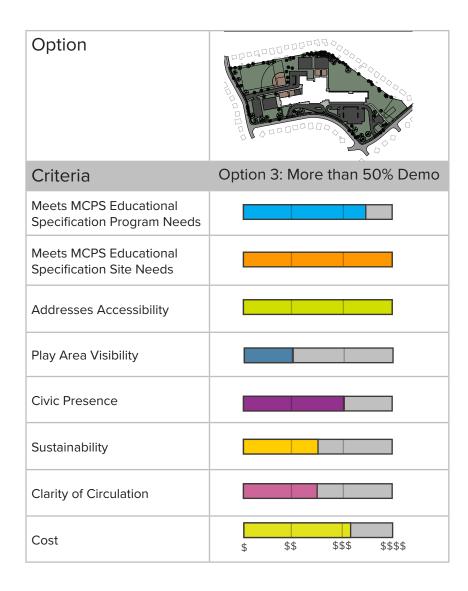
OPTION 3 - MORE THAN 50% DEMO

40,813 GSF - Demolition 28,971 GSF - Renewal 9,966 GSF - Renovation 41,568 GSF - Addition 71% - Efficiency

- Sprinkler system added
- Replaces outdated building systems
- Addresses accessibility issues
- Compartmentalization added with new firewalls
- Design meets ed spec
- · Community-sized gym
- Sustainable building materials
- Simple Internal circulation
- Smaller building footprint
- New daycare drop off

- Lockers cannot fit in existing corridors
- · Low visibility to play areas
- No daylight in Library Media Center
- Type V-B Construction remains
- Multiple parking lots.

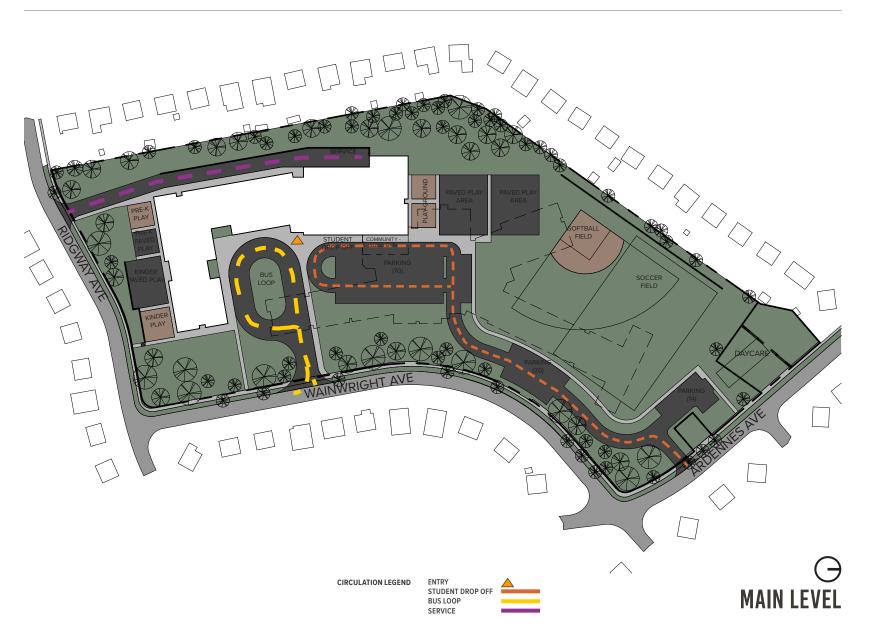
OPTION 4 - REPLACEMENT - SUMMARY

Option 4 -Replacement AREA SUMMARY 79,750 GSF - Demolition 79,668 GSF - Addition 68% - Efficiency Existing building is demolished New building New play areas SCOPE Relocate site program and circulation New location for play areas and fields New location for parking, car and bus drop offs

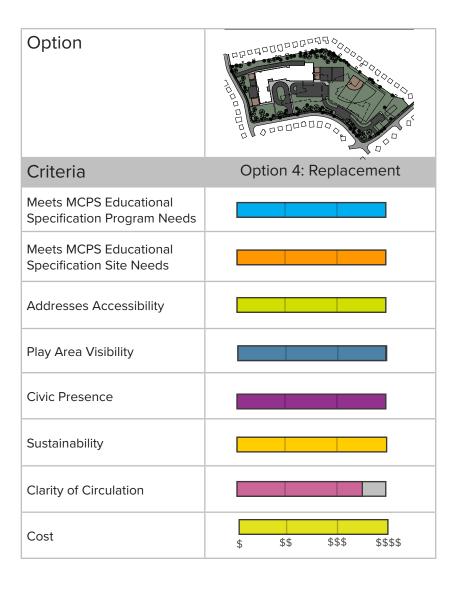
OPTION 4 - REPLACEMENT

79,750 GSF - Demolition 79,668 GSF - Addition 68% - Efficiency

- All new construction
- Fully Accessible
- Design meets ed spec requirements
- Sustainable building materials.
- Small building footprint
- Good room adjacencies
- Good visibility to play areas
- Community gathering space

- High impact to the site = higher cost
- Community-sized gym is an add alternate
- Longer on-site vehicular circulation
- High volume of construction waste.
- Bus traffic on Wainright Avenue.
