# TWINBROOK ELEMENTARY SCHOOL FEASIBILITY STUDY

COMMUNITY MEETING 3 - VIRTUAL  
MONTGOMERY COUNTY PUBLIC SCHOOLS  
JUNE 27, 2025

COOPER CARRY

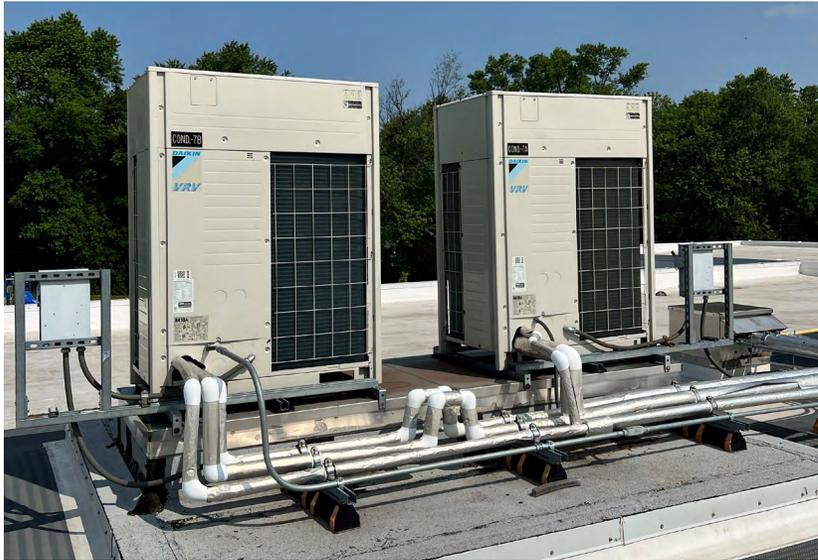
- Entire existing building underwent mechanical system renovation in 2020. New VRF system was installed.
- System is in good condition.

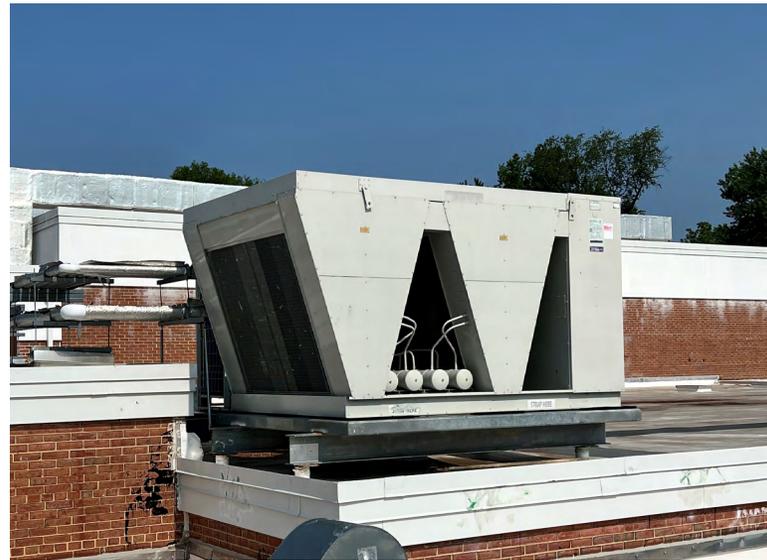
- Existing gym rooftop airhandling unit was installed in 2020 as part of the mechanical system renovation.
- System is in good condition.

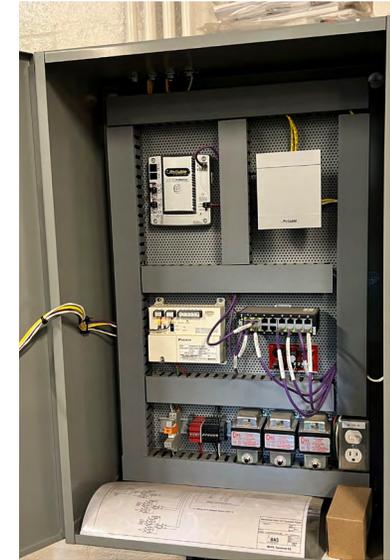
- Existing ATC (automatic temperature control) system was installed in 2020.

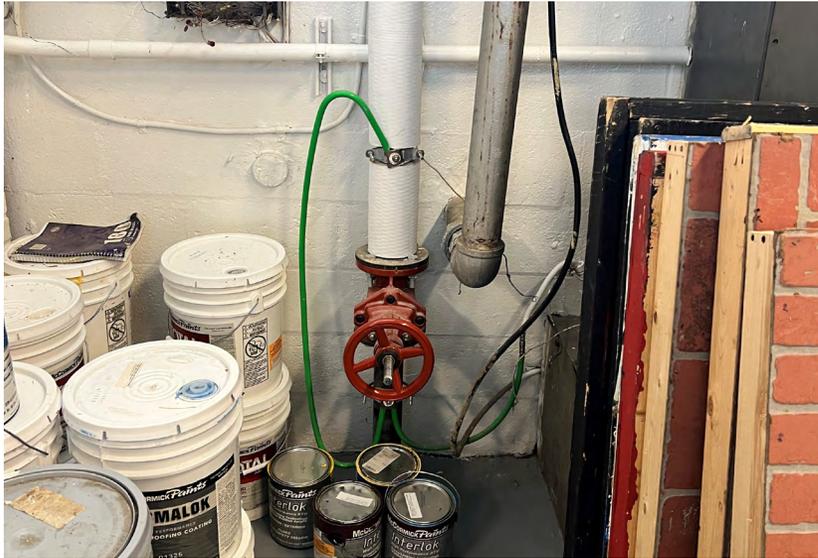
- Majority of domestic water piping is original or installed between 1953 and 1972.
- Piping system and components have exceeded their useful life.

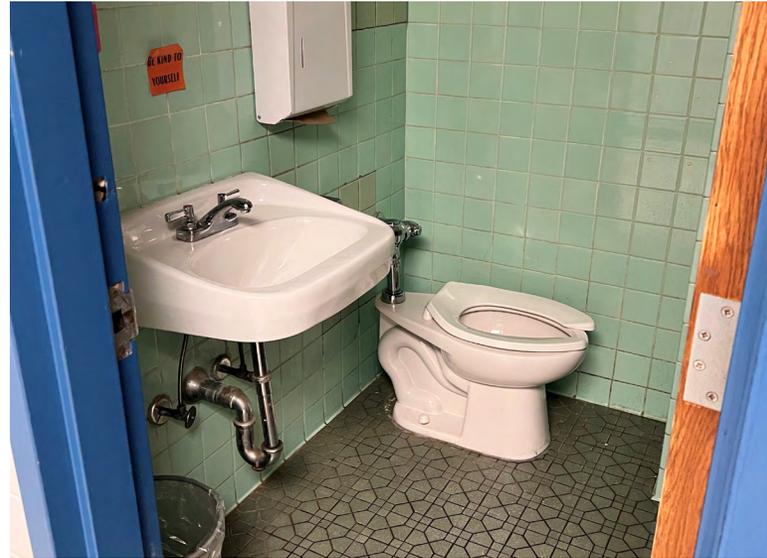
- Existing above and below-grade sanitary, waste, vent, and storm water piping are original to date of building area served.
- Existing systems are beyond useful life.
- Fixtures are in fair condition.

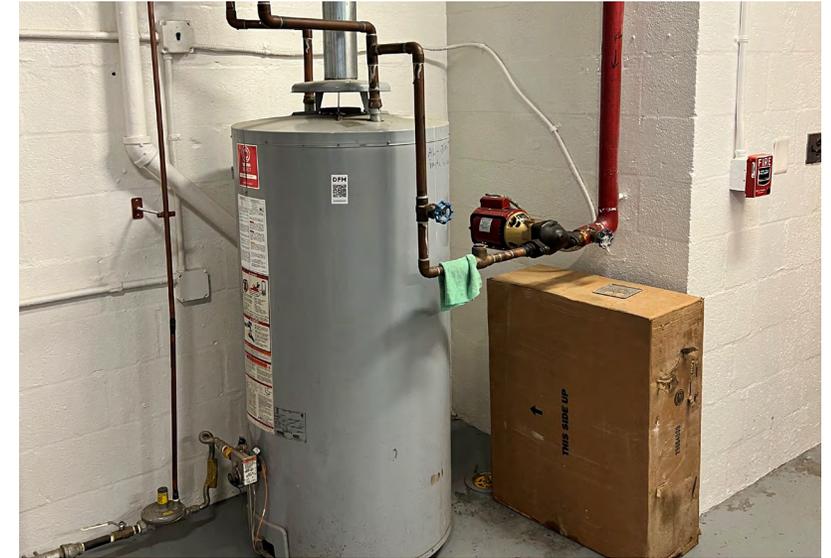
- Existing hot water heaters in several locations date to 2010/2011 and in fair condition. Newest heater installed in 2024 and is in good condition.
- Minimal surplus capacity exists for existing hot water heaters.

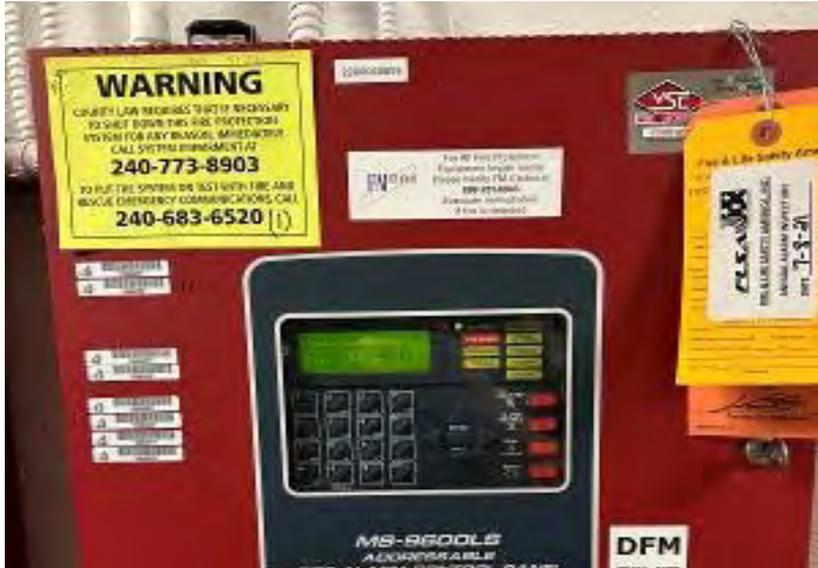
- Sprinkler coverage is limited, serves storage areas, the kiln room, & stage only.

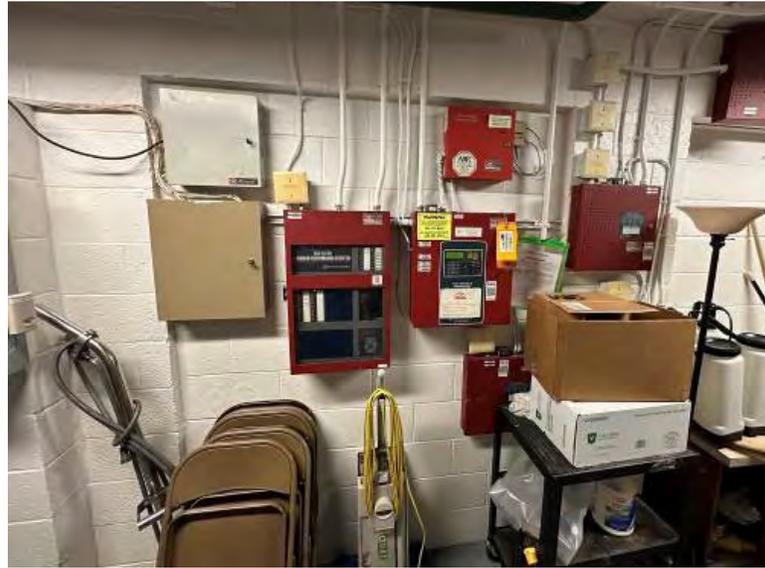
- Fire detection and alarm systems were installed in 2010.

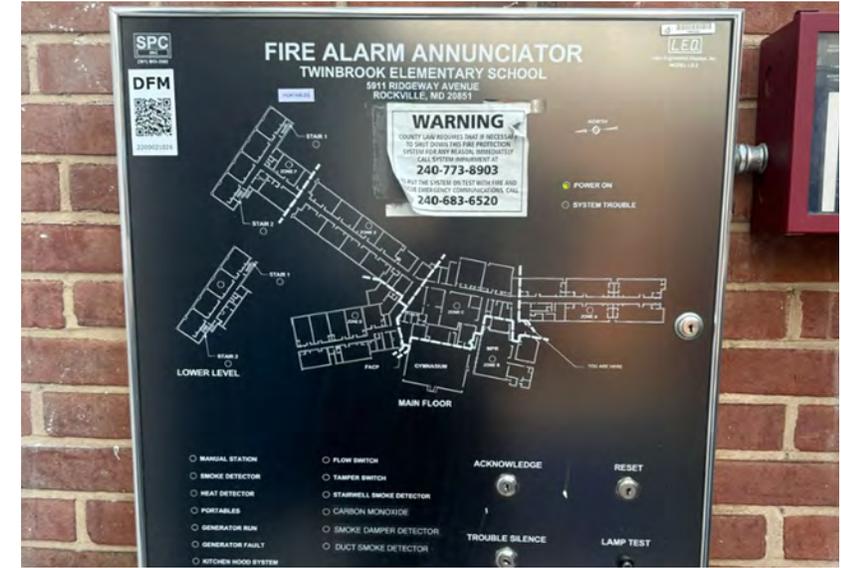
- A fire alarm annunciator panel (FAAP) is located in the main entrance vestibule. Fire alarm devices include manual pull stations, smoke detectors, and audible and visual notification devices.

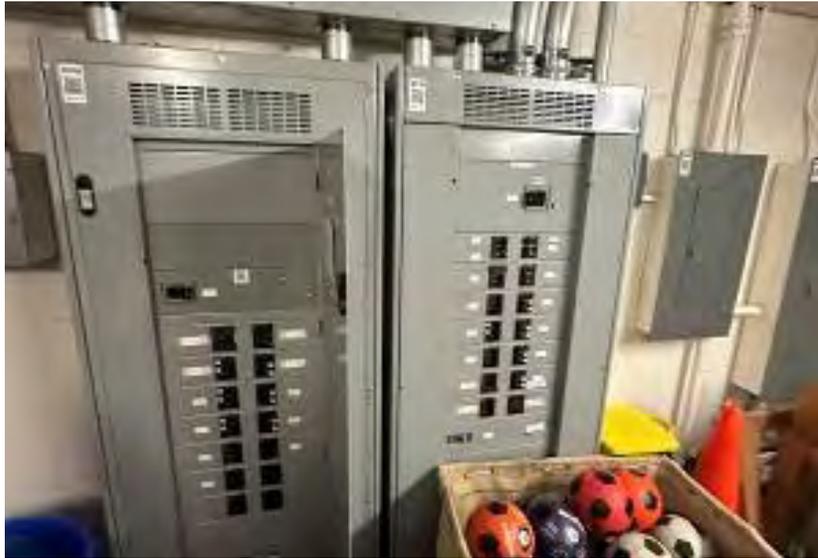
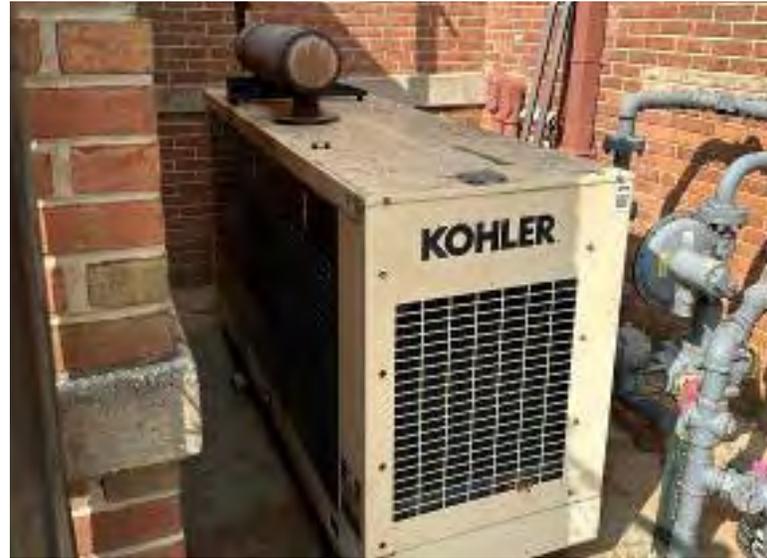
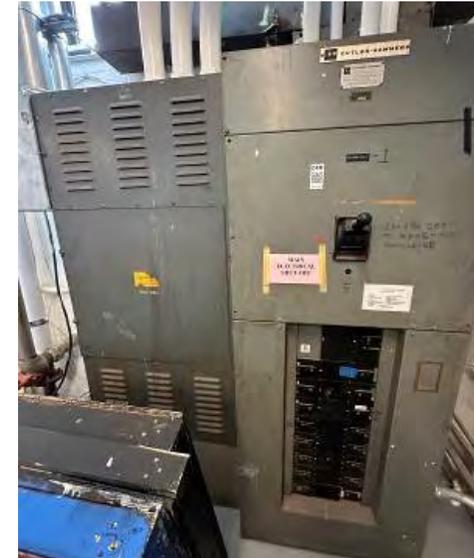
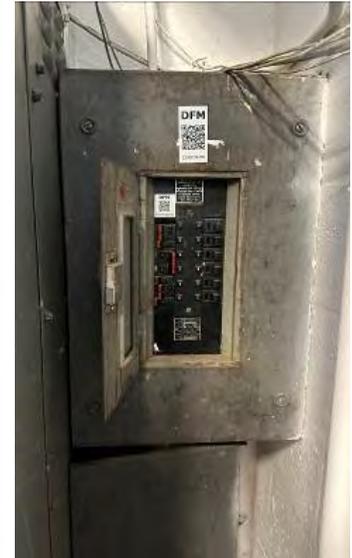
- Electrical equipment varies in age, majority of equipment is from 1951 with more added during 1961 and 1971 renovations and are obsolete.
- Electrical equipment from 2020 HVAC system upgrades is in fair to good condition.

- Existing 35 kW Generator was installed in 2000.
- Generator serves an automatic transfer switch located inside main boiler room.

- Main electrical switchboard is 54-years old and obsolete.

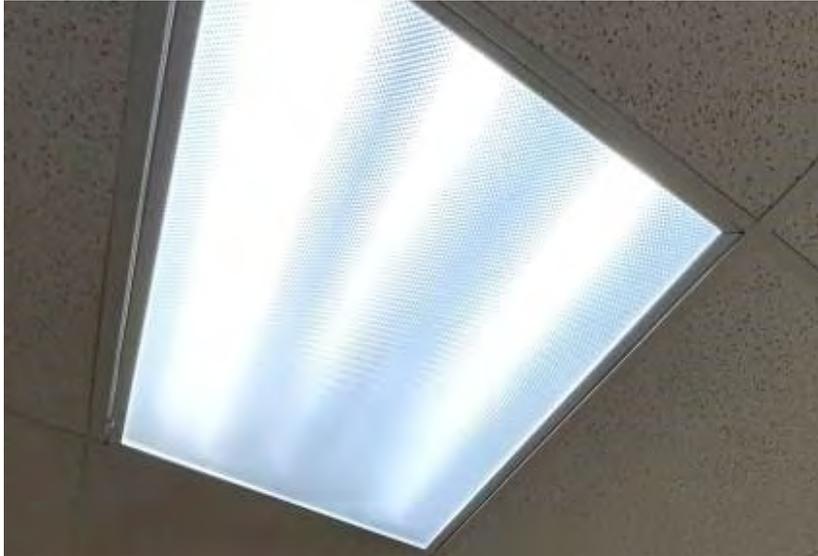
- Fluorescent lighting is used throughout the school.
- Gymnasium has high bay metal halide lighting fixtures.

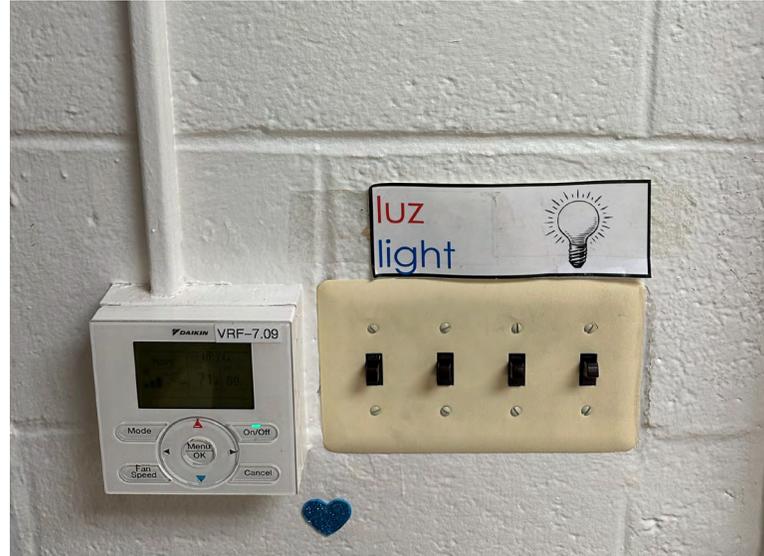
- Classrooms use line voltage toggle switches zoned for reduction in light. No occupancy sensors currently.

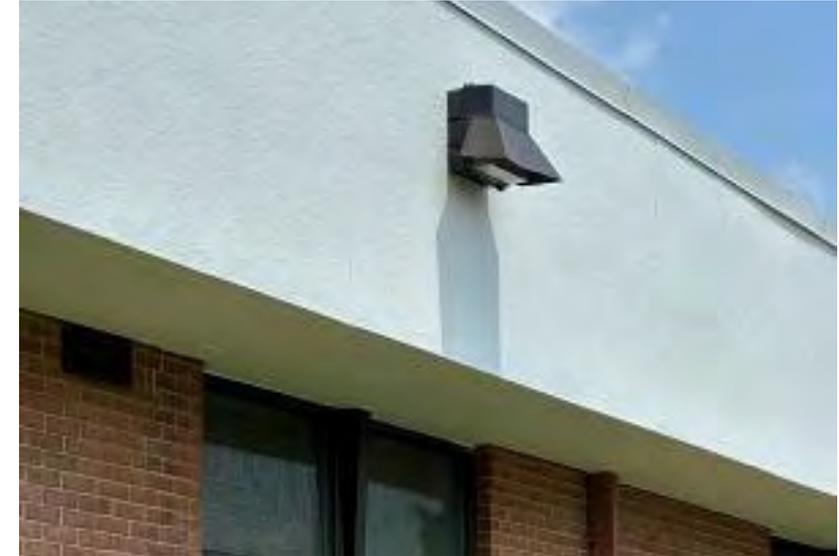
- Exterior lighting consists of pole-mounted lighting fixtures, building-mounted wall packs with make-shift shielding, and canopy lighting fixtures utilizing high-intensity discharge lamps.

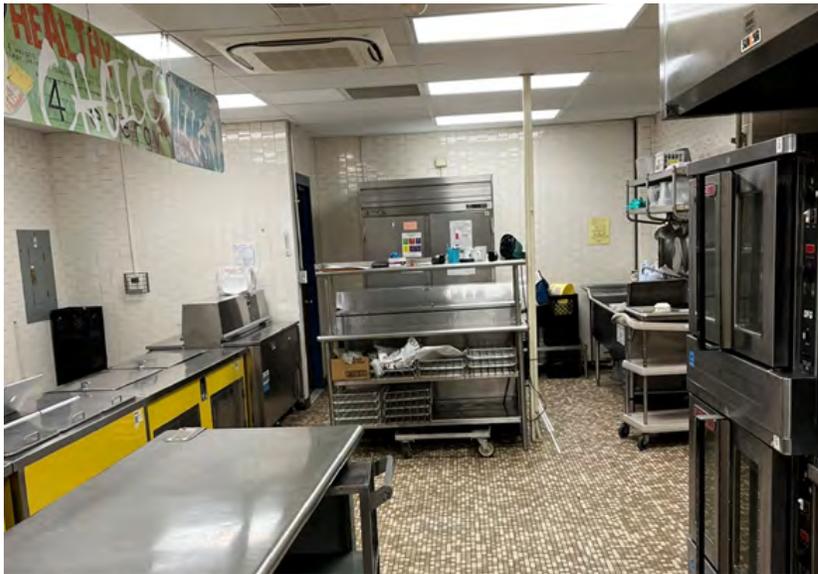
- Kitchen has single ceiling cassette type VRF terminal unit.
- Size of kitchen does not meet Ed Spec requirements
- Cooking hood and exhaust fan appear to be from 2003.

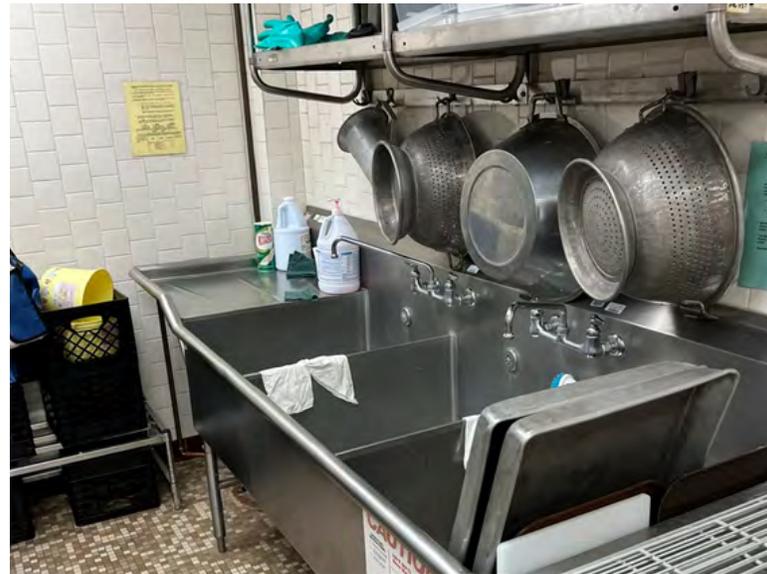
- Kitchen equipment appears to be in fair condition.

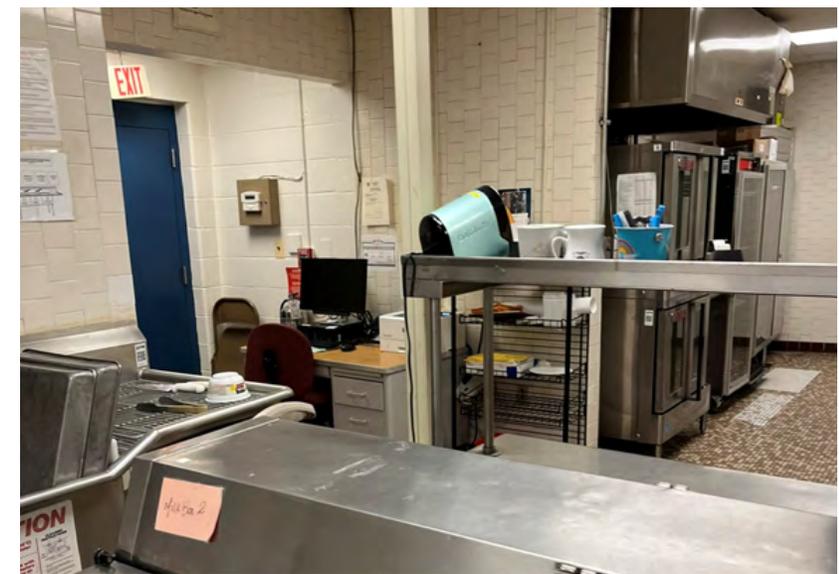
- Kitchen is missing office space & locker room area for staff.
- Restroom serving kitchen is not ADA compliant.

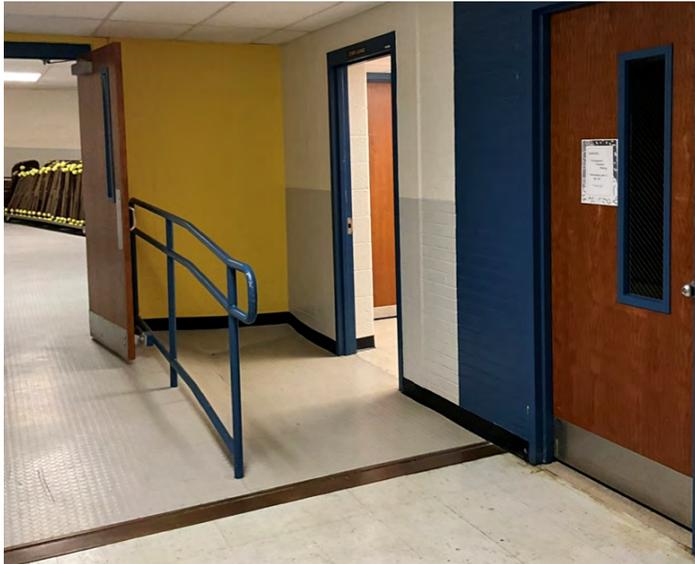
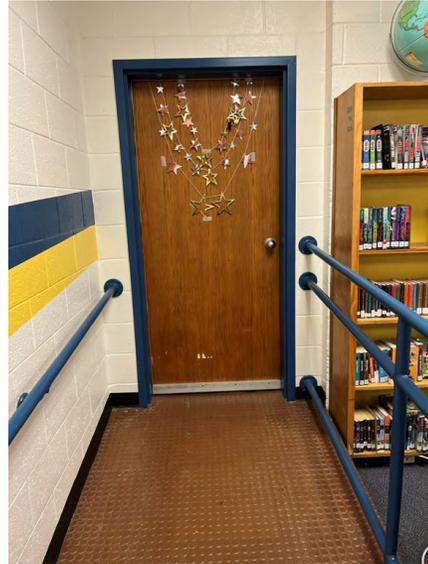
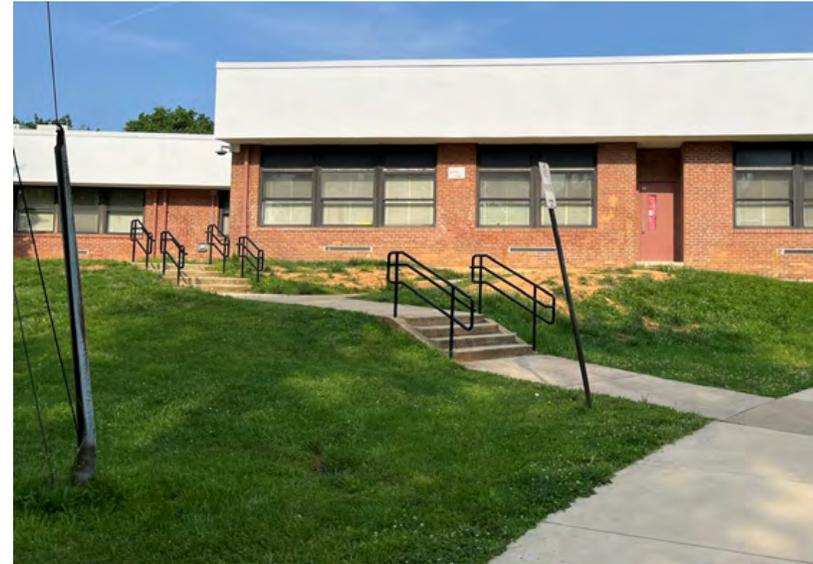
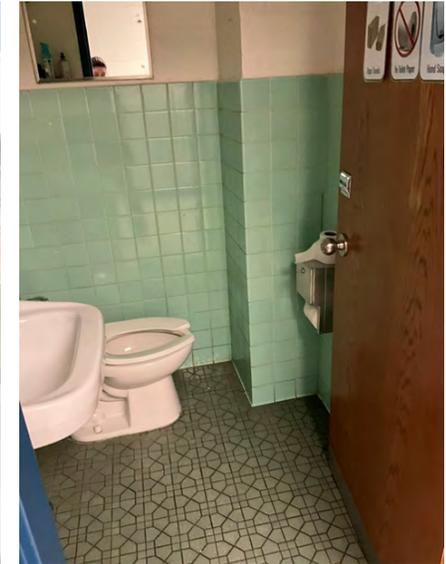
- Existing building has three occupied levels, and 2-stories, connected via stairs and ramps.
- Existing ramps are not ADA compliant.
- There is no existing elevator to access the lower level classrooms.

- Ramps do not have appropriate landings or are too steep.
- Exterior access to school on Wainwright Ave side is not ADA compliant.
- Interior building signage is not ADA compliant.

- Staff restrooms are not ADA compliant.
- Most student plumbing fixtures are not ADA compliant.
- No ADA stalls or restrooms present in entire school, ambulatory stalls only in group restrooms.

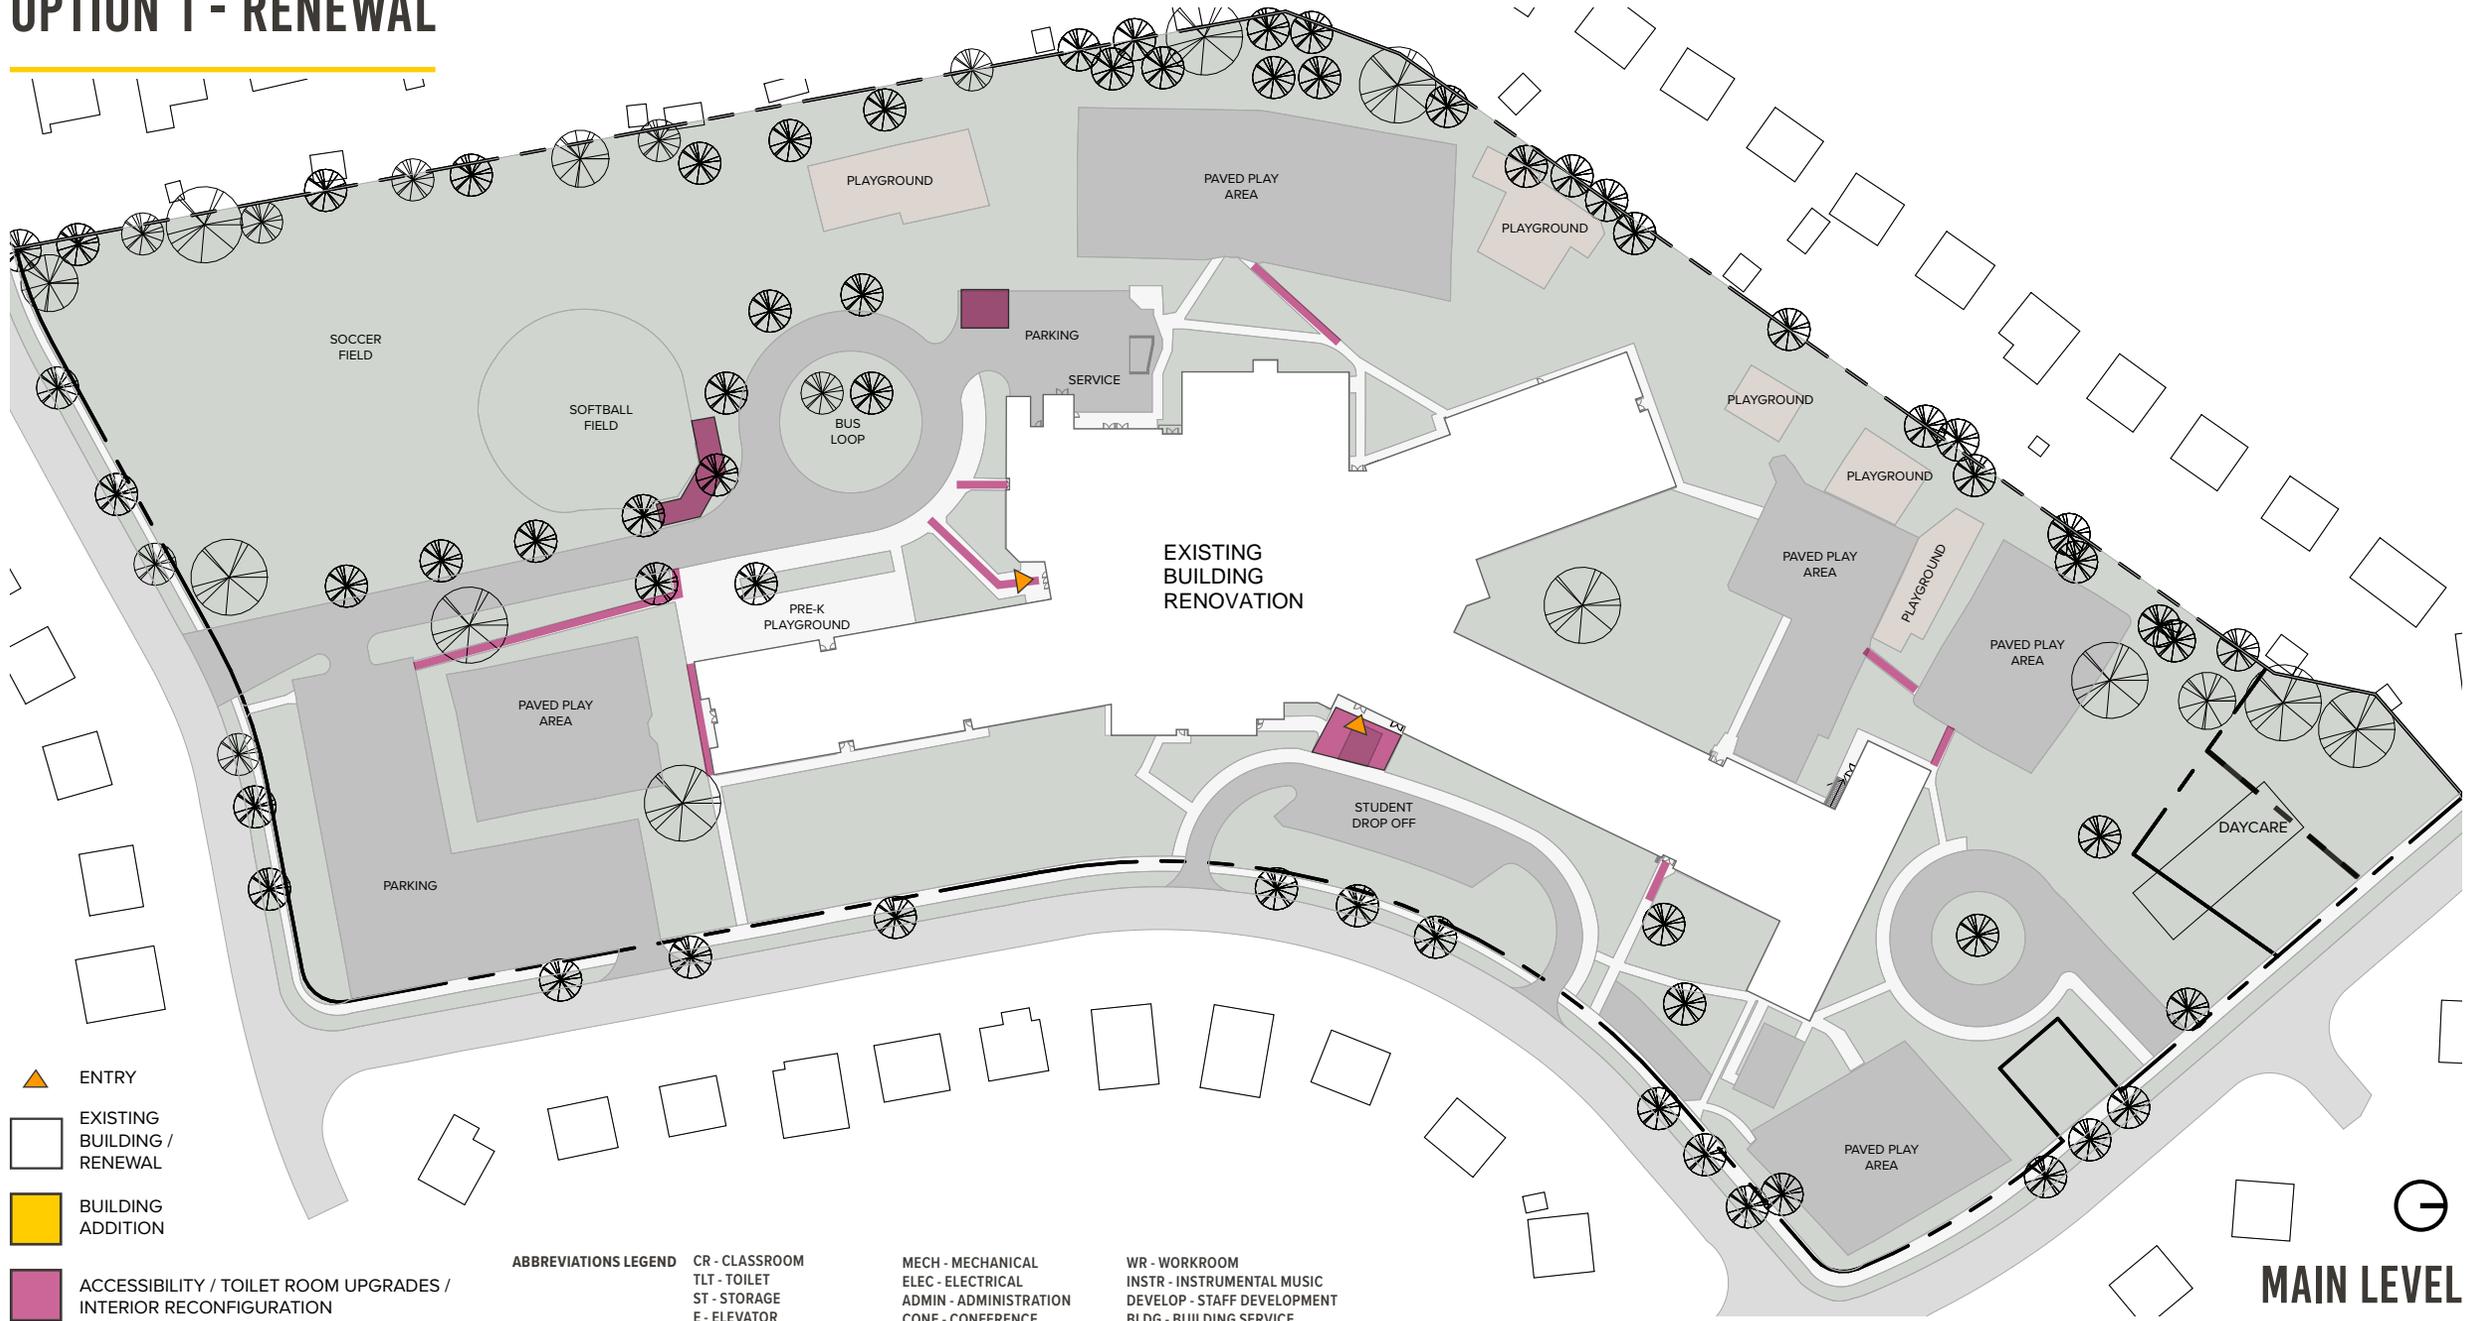
# OPTION 1 - RENEWAL

ENTRY
-

EXISTING BUILDING / RENEWAL
-

BUILDING ADDITION
-

ACCESSIBILITY / TOILET ROOM UPGRADES / INTERIOR RECONFIGURATION

<p>Option 1 - Renewal</p>
SCOPE	<ul style="list-style-type: none"> <li>Existing parking and play areas remain unchanged</li> <li>Electrical &amp; Plumbing system replacement</li> <li>Renovate finishes</li> <li>Upgrade existing restrooms to meet MCPS standards</li> <li>Renovate existing building to meet accessibility standards.</li> <li>Elevator added for lower level access</li> </ul> <p>70,932 GSF - Renewal 8,818 GSF - Renovation</p>
PROS	<ul style="list-style-type: none"> <li>Sprinkler system added</li> <li>Replaces outdated building systems</li> <li>Addresses accessibility issues</li> <li>Community-sized gym remains</li> </ul>
CONS	<ul style="list-style-type: none"> <li>Does not provide the following program spaces: Dual-Purpose Room, Music, &amp; Instrumental Music</li> <li>Administration, Health Services, 5 Classrooms, Multi-Purpose Room, &amp; Kitchen all undersized per ed spec.</li> <li>Lockers in corridors cannot be accommodated</li> </ul>

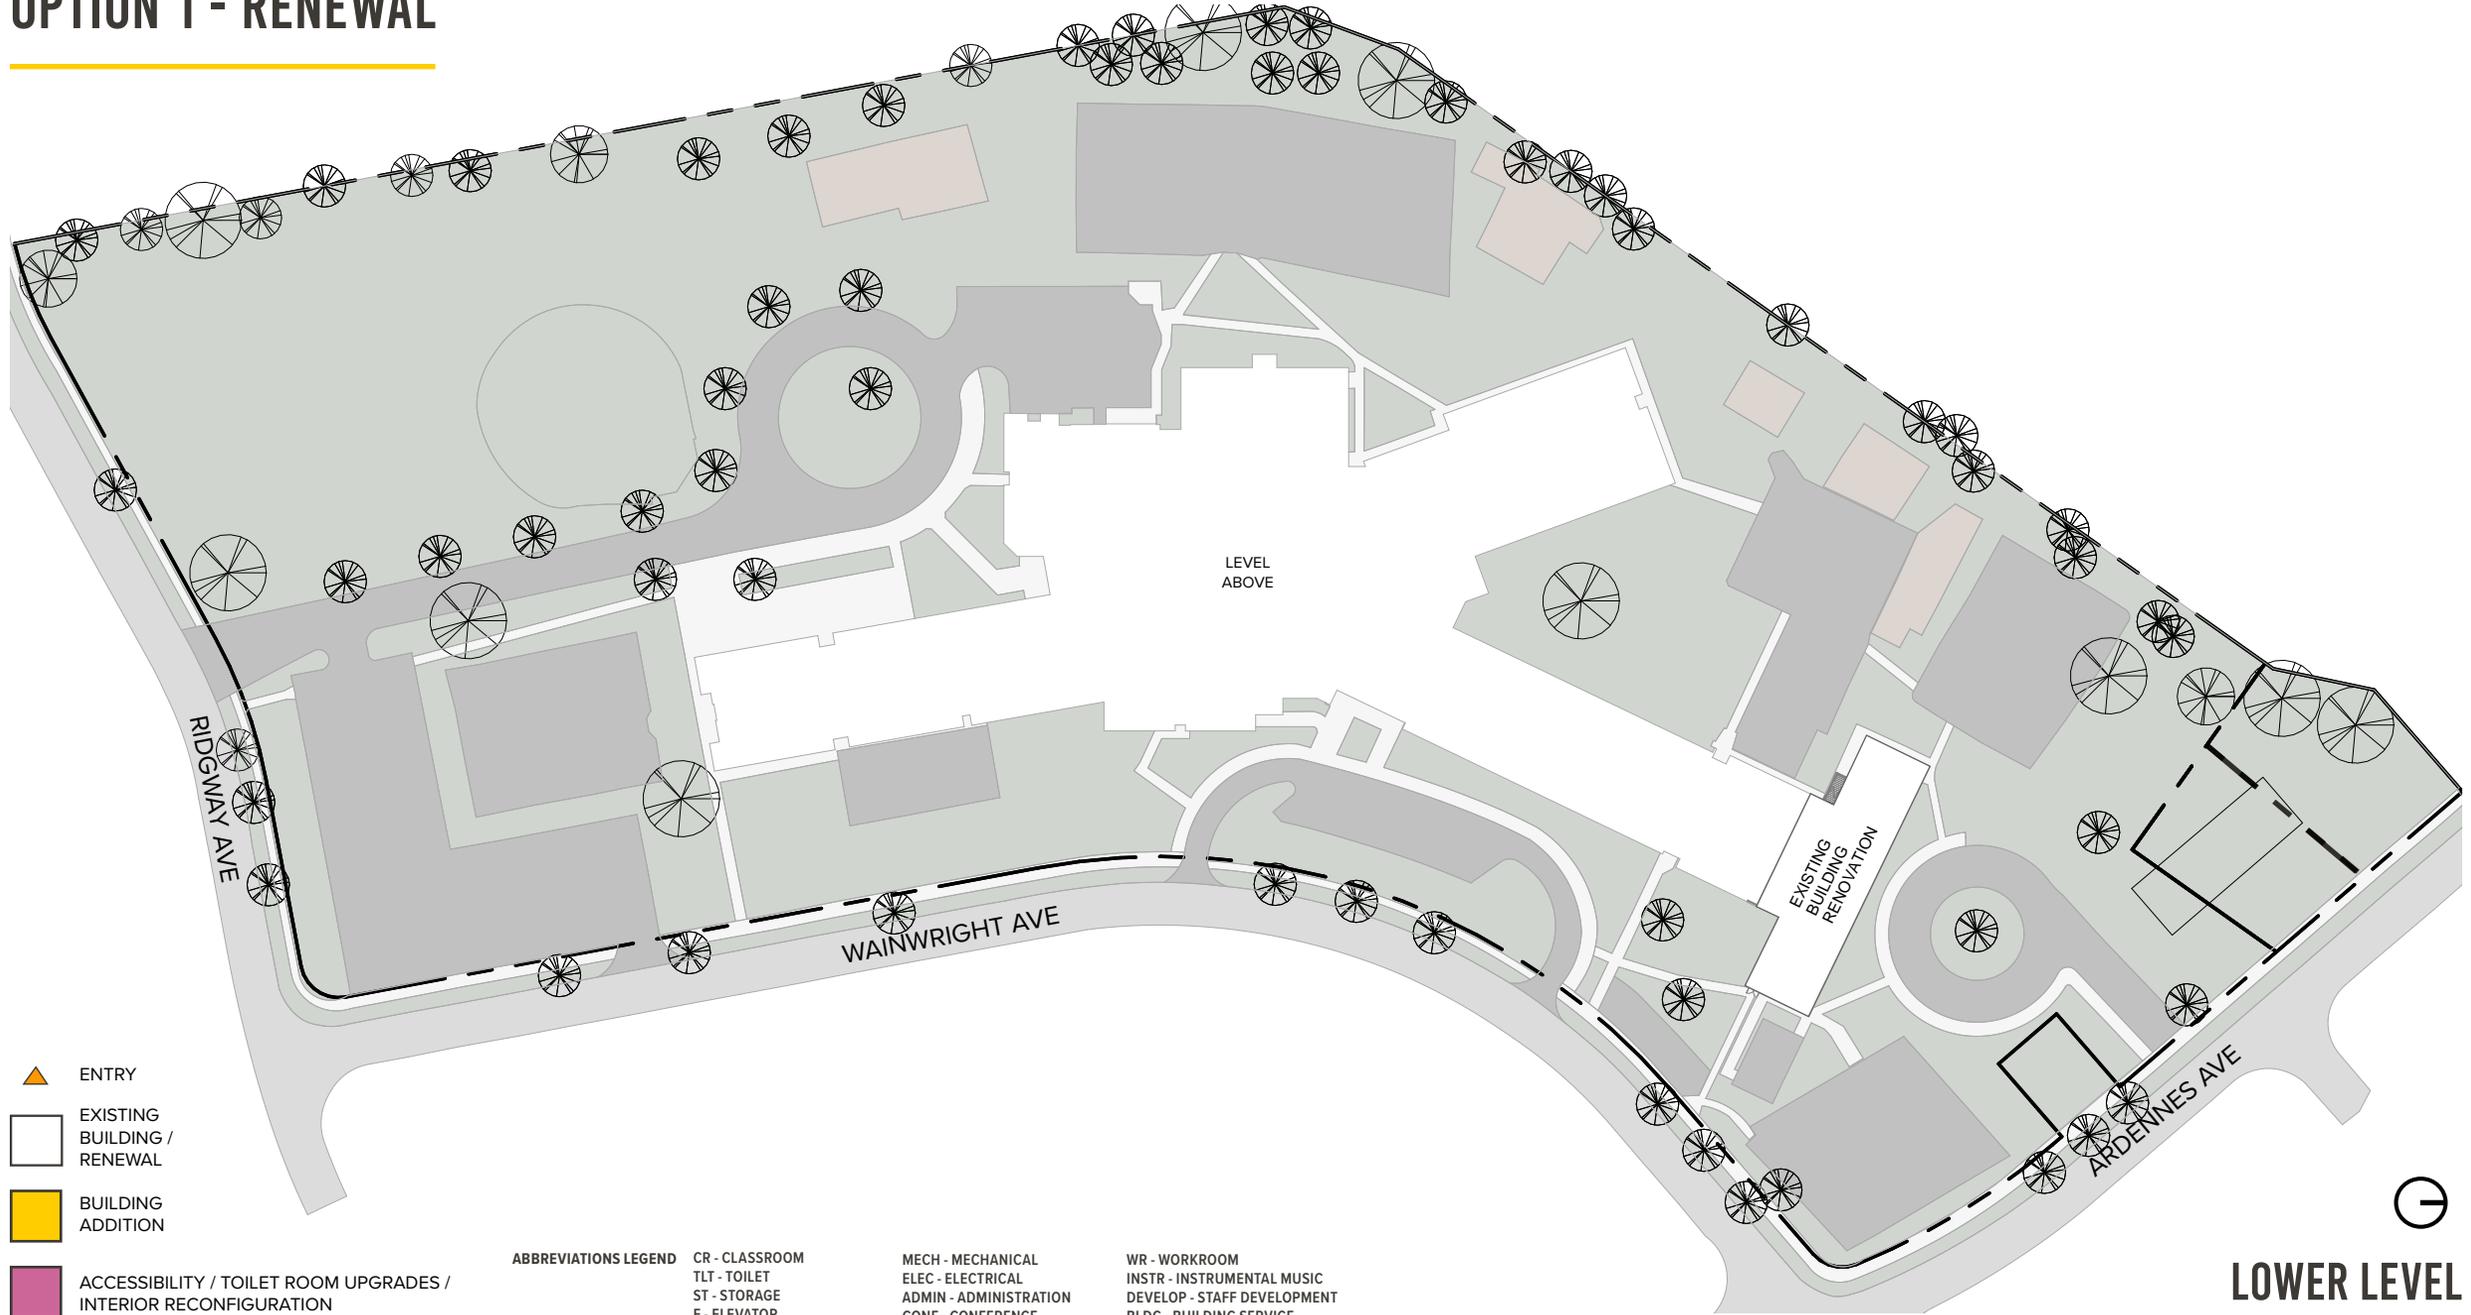
# OPTION 1 - RENEWAL

ENTRY
-

EXISTING BUILDING / RENEWAL
-

BUILDING ADDITION
-

ACCESSIBILITY / TOILET ROOM UPGRADES / INTERIOR RECONFIGURATION

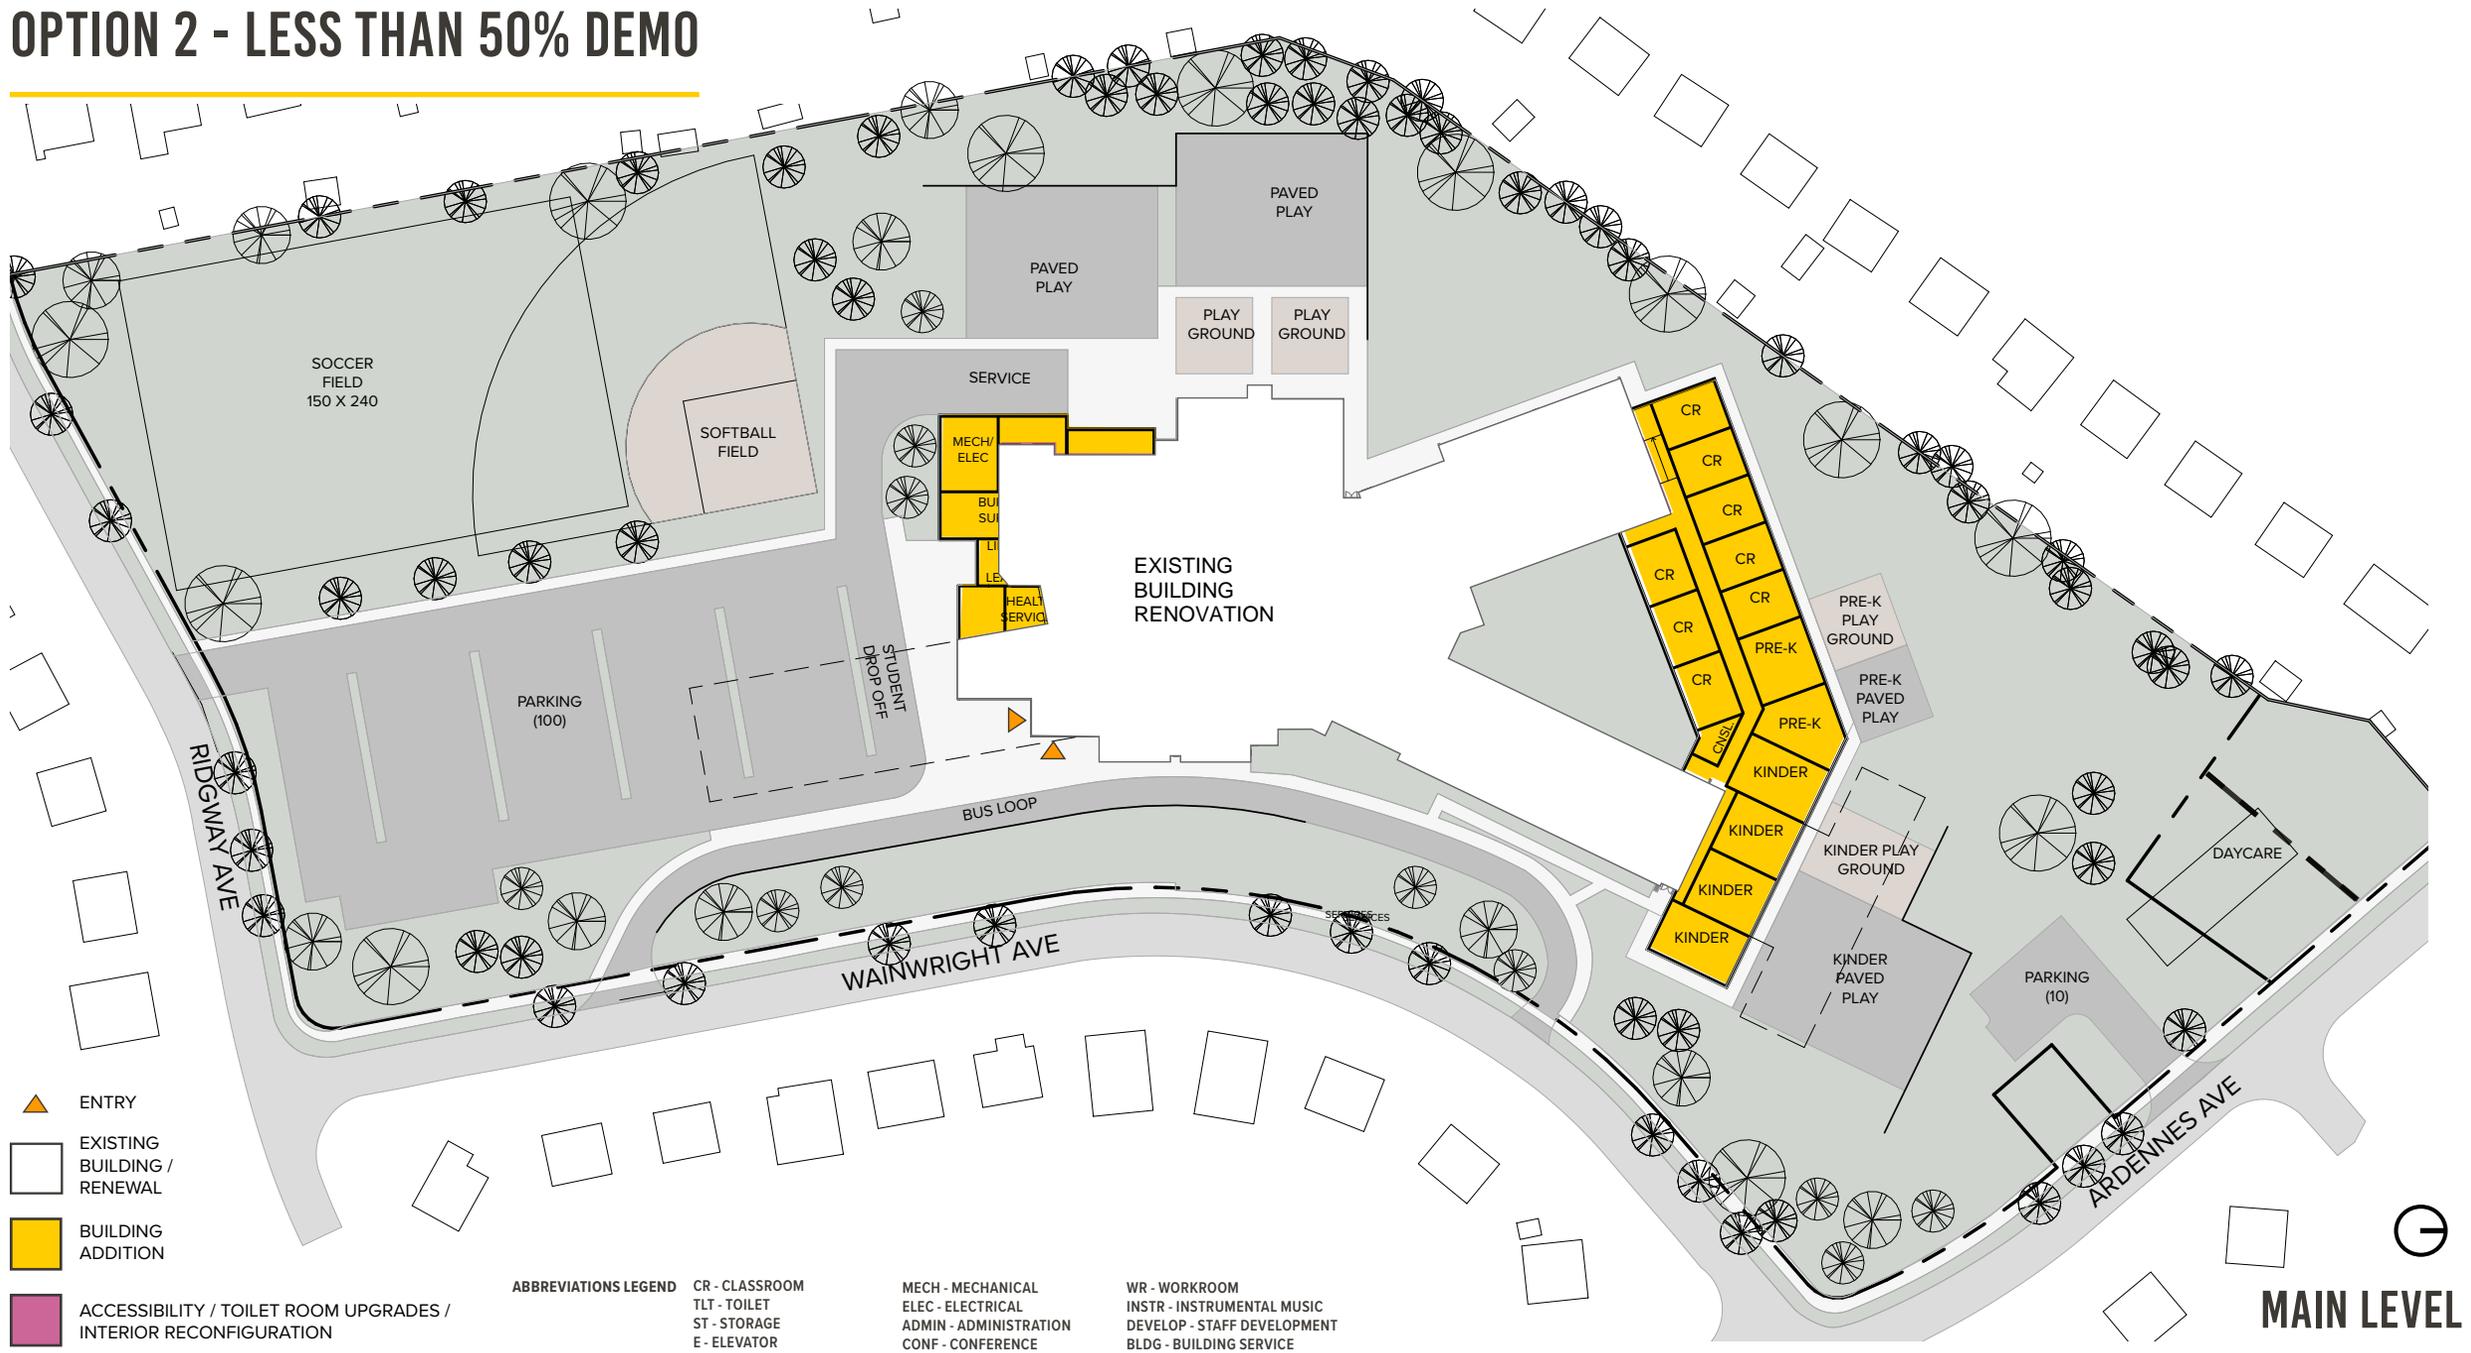
# OPTION 2 - LESS THAN 50% DEMO

ENTRY
-

EXISTING BUILDING / RENEWAL
-

BUILDING ADDITION
-

ACCESSIBILITY / TOILET ROOM UPGRADES / INTERIOR RECONFIGURATION

Option 2 - Less than 50% Demo	
SCOPE	<ul style="list-style-type: none"> <li>Less than 50% of existing building would be demolished and additions would be added to meet program requirements.</li> <li>This option is 1-story.</li> <li>Electrical &amp; Plumbing system replacement</li> <li>Renovate finishes</li> <li>Upgrade existing restrooms to meet MCPS standards</li> <li>Renovate existing building to meet accessibility standards.</li> </ul> <p>30,913 GSF - Demolition 36,645 GSF - Renewal 12,192 GSF - Renovation 30,052 GSF - Addition</p>
PROS	<ul style="list-style-type: none"> <li>Sprinkler system added</li> <li>Replaces outdated building systems</li> <li>Addresses accessibility issues</li> <li>Design meets ed spec</li> <li>Community-sized gym remains</li> </ul>
CONS	<ul style="list-style-type: none"> <li>Inefficiencies in existing building to address accessibility and new restroom layout</li> <li>The required number of lockers in corridors cannot be accommodated.</li> </ul>

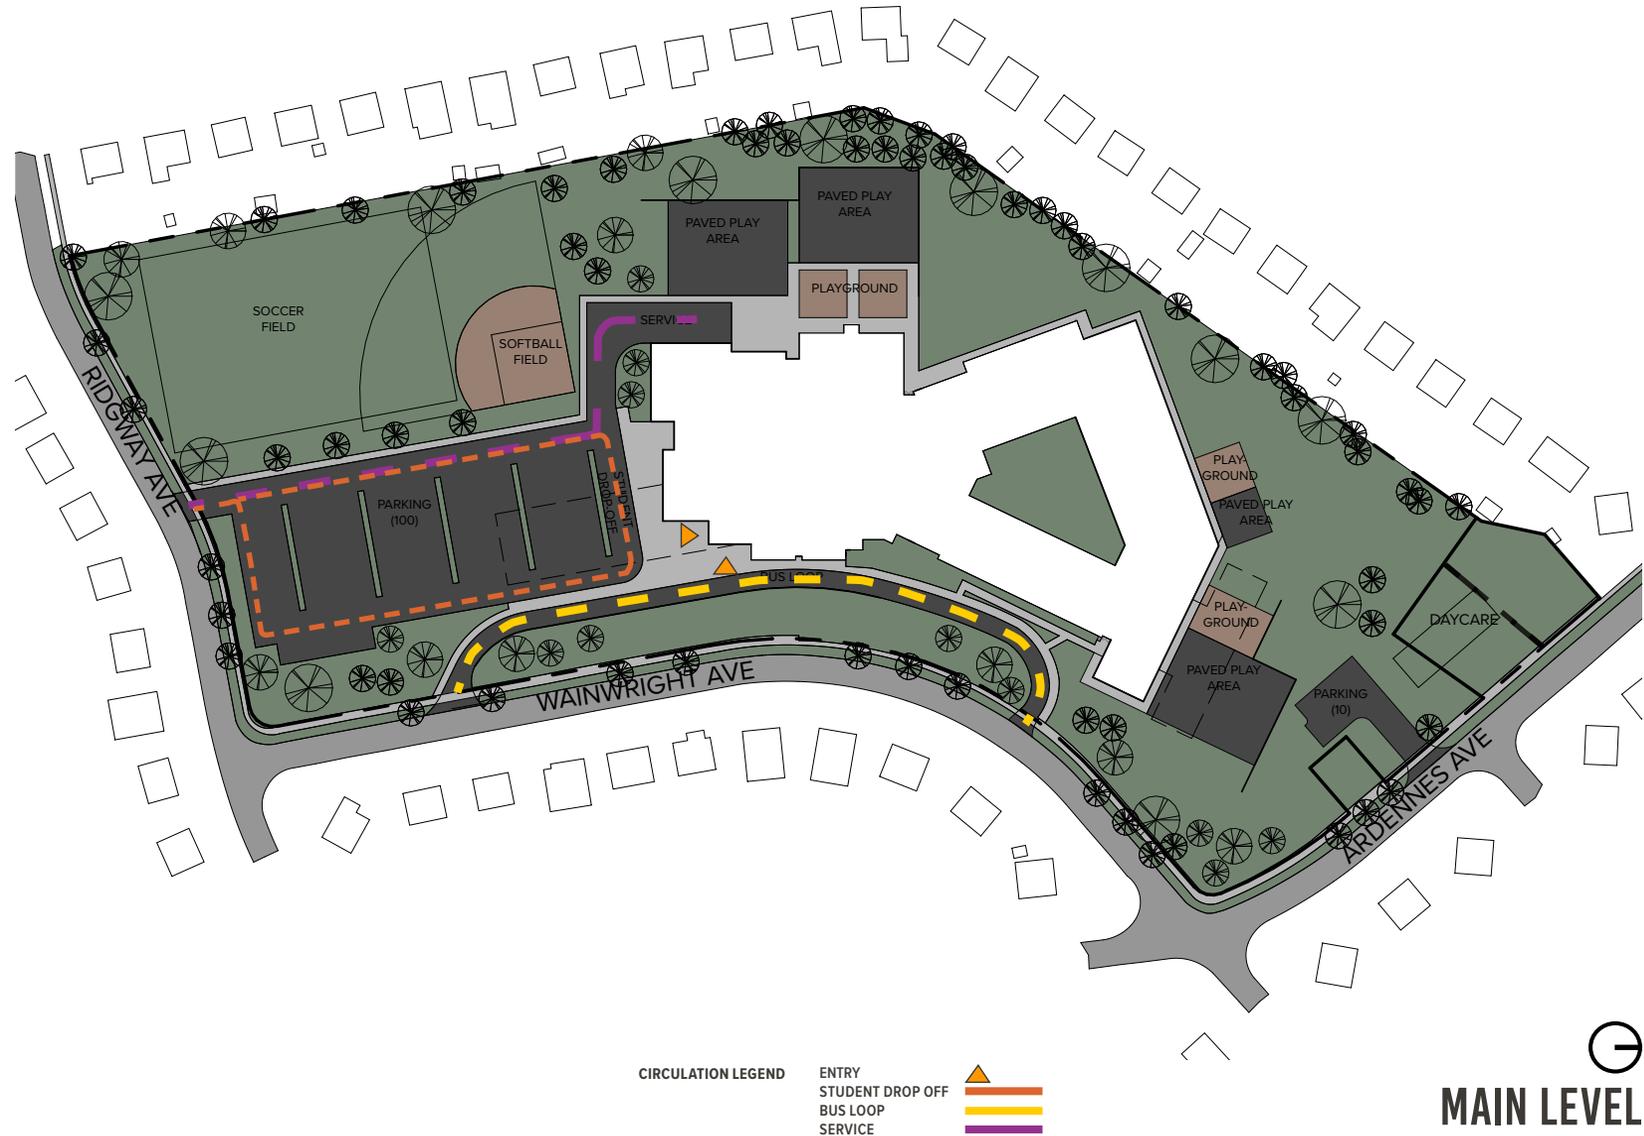
# OPTION 3 - MORE THAN 50% DEMO

<p>Option 3 - More than 50% Demo</p>
SCOPE	<ul style="list-style-type: none"> <li>More than 50% of existing building is demolished.</li> <li>Additions include a 2-story classroom wing and expanded kitchen and music suite on the SW corner of the building.</li> <li>Electrical &amp; Plumbing system replacement</li> <li>Renovate finishes</li> <li>Upgrades to existing restrooms to meeting MCPS standards</li> <li>Renovate existing building to meet accessibility standards.</li> </ul> <p>40,813 GSF - Demolition 29,021 GSF - Renewal 9,916 GSF - Renovation 42,483 GSF - Addition</p>
PROS	<ul style="list-style-type: none"> <li>Sprinkler system added</li> <li>Replaces outdated building systems</li> <li>Addresses accessibility issues</li> <li>Design meets ed spec</li> <li>Community-sized gym remains</li> </ul>
CONS	<ul style="list-style-type: none"> <li>Inefficiencies in existing building to address accessibility and new restroom layout</li> <li>The required number of lockers in corridors cannot be accommodated.</li> </ul>

Options	Scope	Pros	Cons
<p style="text-align: center;">Option 3 - More than 50% Demo</p>	<ul style="list-style-type: none"> <li>• More than 50% of existing building is demolished.</li> <li>• Additions include a 2-story classroom wing and expanded kitchen and music suite on the SW corner of the building.</li> <li>• Electrical &amp; Plumbing system replacement</li> <li>• Renovate finishes</li> <li>• Upgrades to existing restrooms to meeting MCPS standards</li> <li>• Renovate existing building to meet accessibility standards.</li> </ul> <p>40,813 GSF - Demolition 29,021 GSF - Renewal 9,916 GSF - Renovation 42,483 GSF - Addition</p>	<ul style="list-style-type: none"> <li>• Sprinkler system added</li> <li>• Replaces outdated building systems</li> <li>• Addresses accessibility issues</li> <li>• Design meets ed spec</li> <li>• Community-sized gym remains</li> </ul>	<ul style="list-style-type: none"> <li>• Inefficiencies in existing building to address accessibility and new restroom layout</li> <li>• The required number of lockers in corridors cannot be accommodated.</li> </ul>
