# TWINBROOK ELEMENTARY SCHOOL FEASIBILITY STUDY

COMMUNITY MEETING 3 - VIRTUAL  
MONTGOMERY COUNTY PUBLIC SCHOOLS  
JUNE 27, 2025

COOPER CARRY

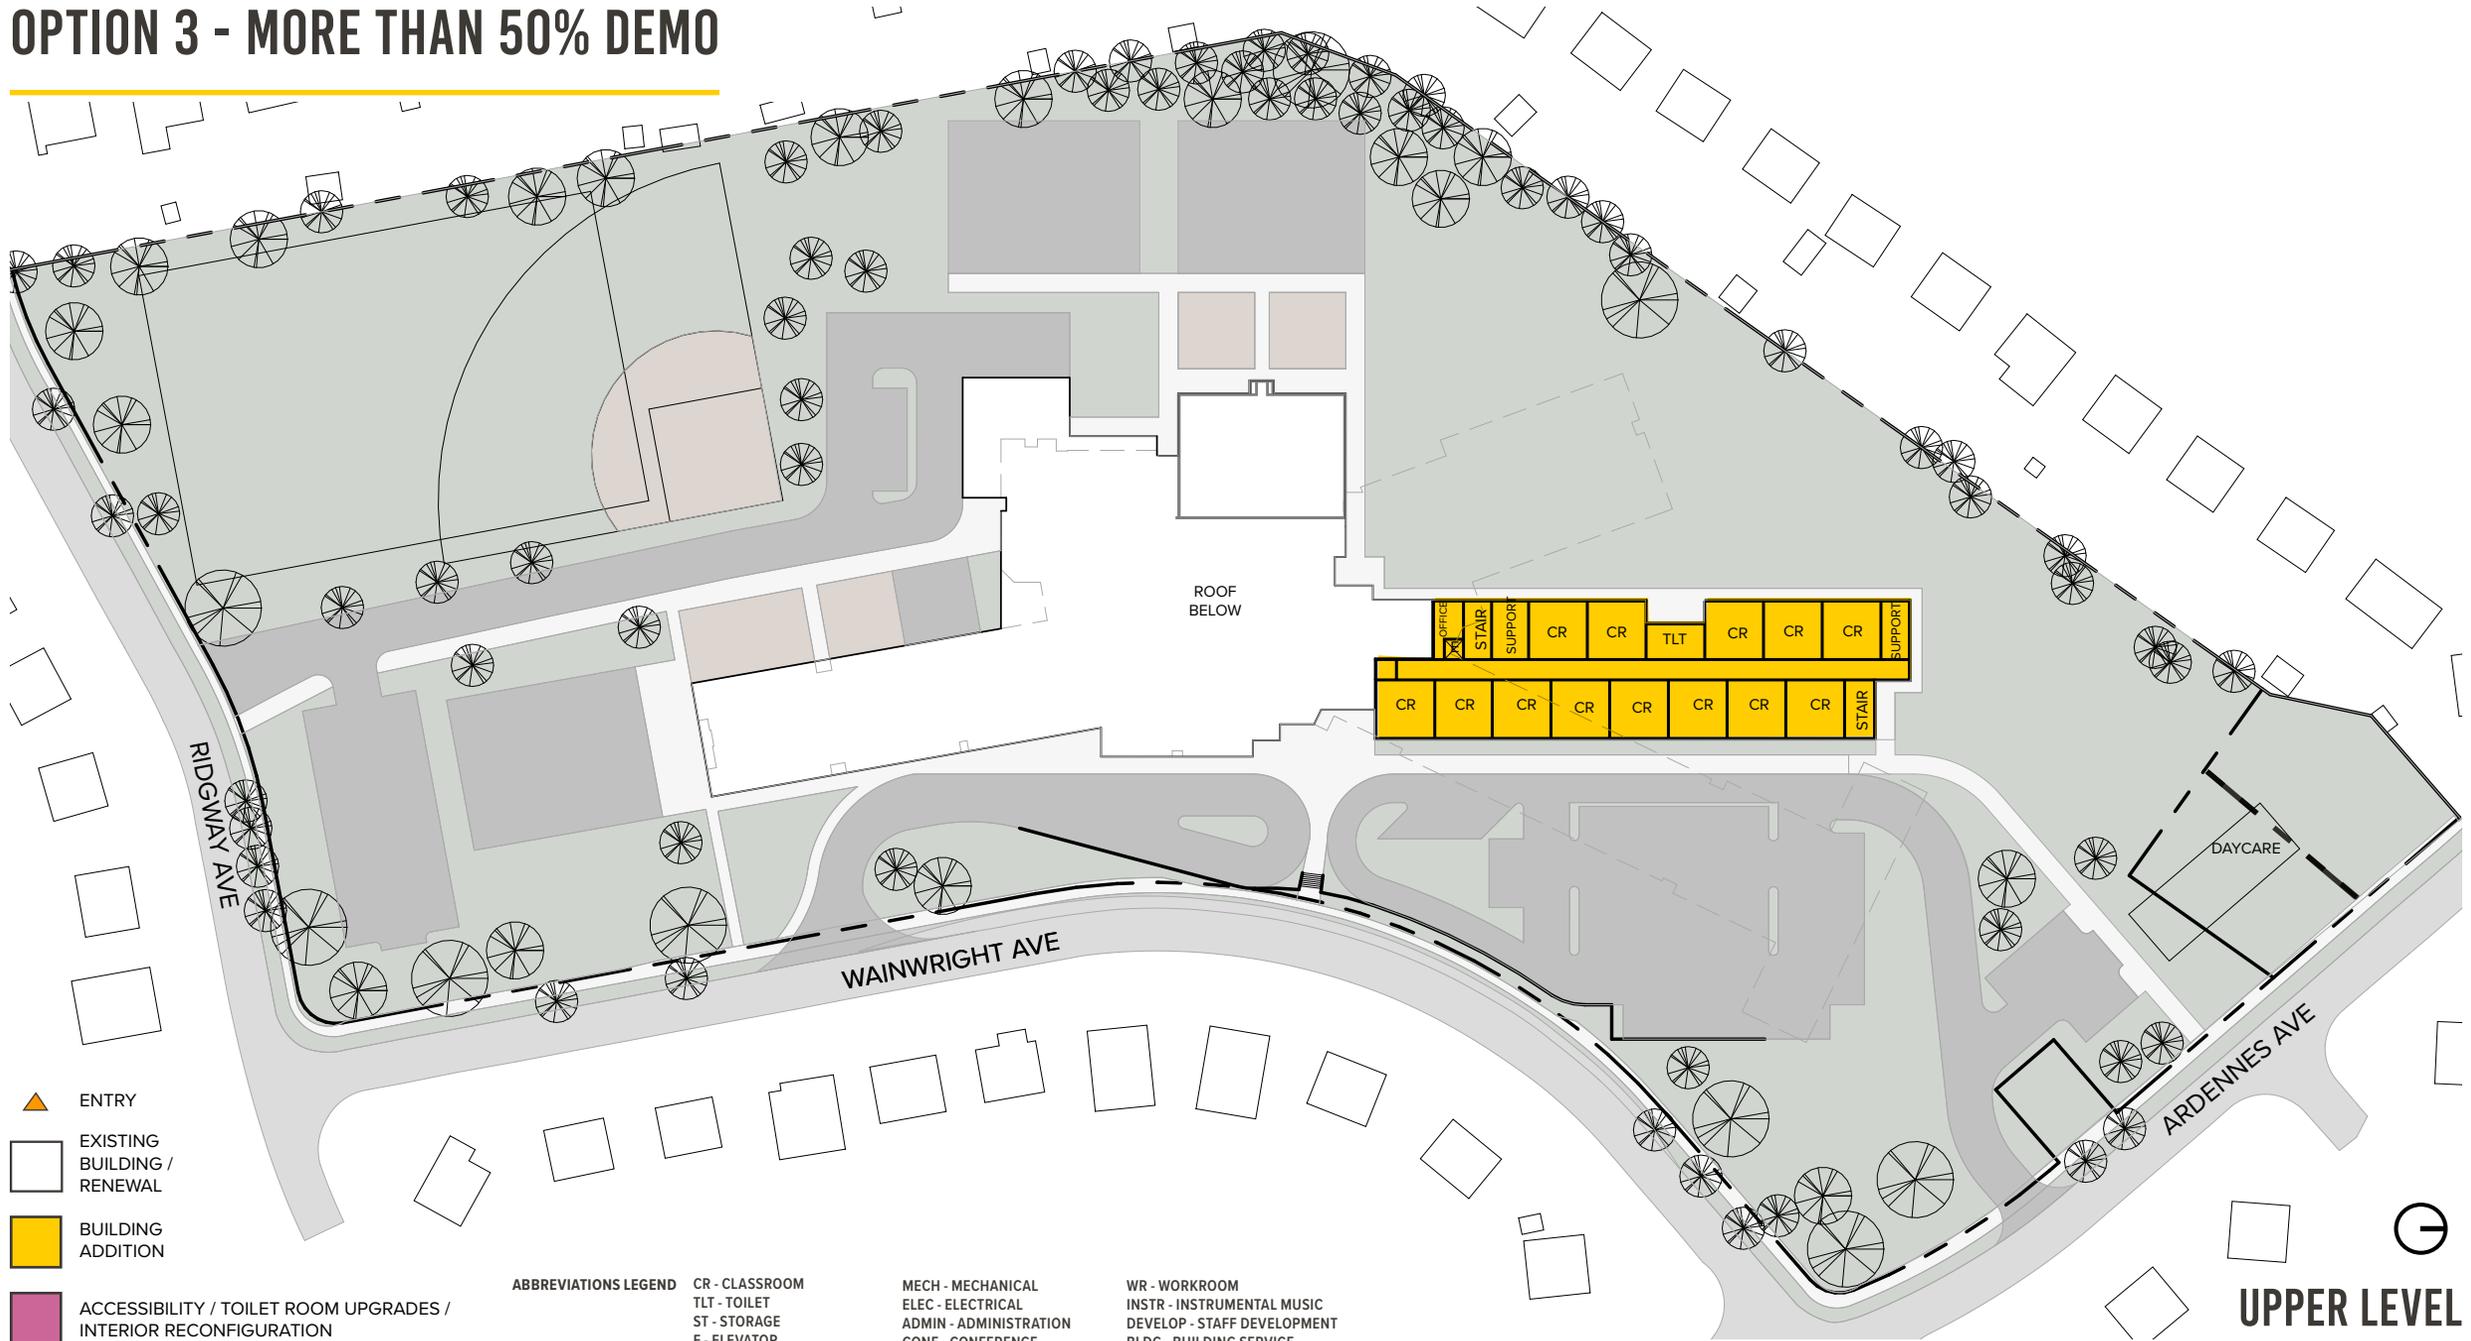
# OPTION 3 - MORE THAN 50% DEMO

ENTRY
-

EXISTING BUILDING / RENEWAL
-

BUILDING ADDITION
-

ACCESSIBILITY / TOILET ROOM UPGRADES / INTERIOR RECONFIGURATION

<p>Option 3 - More than 50% Demo</p>
SCOPE	<ul style="list-style-type: none"> <li>More than 50% of existing building is demolished.</li> <li>Additions include a 2-story classroom wing and expanded kitchen and music suite on the SW corner of the building.</li> <li>Electrical &amp; Plumbing system replacement</li> <li>Renovate finishes</li> <li>Upgrades to existing restrooms to meeting MCPS standards</li> <li>Renovate existing building to meet accessibility standards.</li> </ul> <p>40,813 GSF - Demolition 29,021 GSF - Renewal 9,916 GSF - Renovation 42,483 GSF - Addition</p>
PROS	<ul style="list-style-type: none"> <li>Sprinkler system added</li> <li>Replaces outdated building systems</li> <li>Addresses accessibility issues</li> <li>Design meets ed spec</li> <li>Community-sized gym remains</li> </ul>
CONS	<ul style="list-style-type: none"> <li>Inefficiencies in existing building to address accessibility and new restroom layout</li> <li>The required number of lockers in corridors cannot be accommodated.</li> </ul>

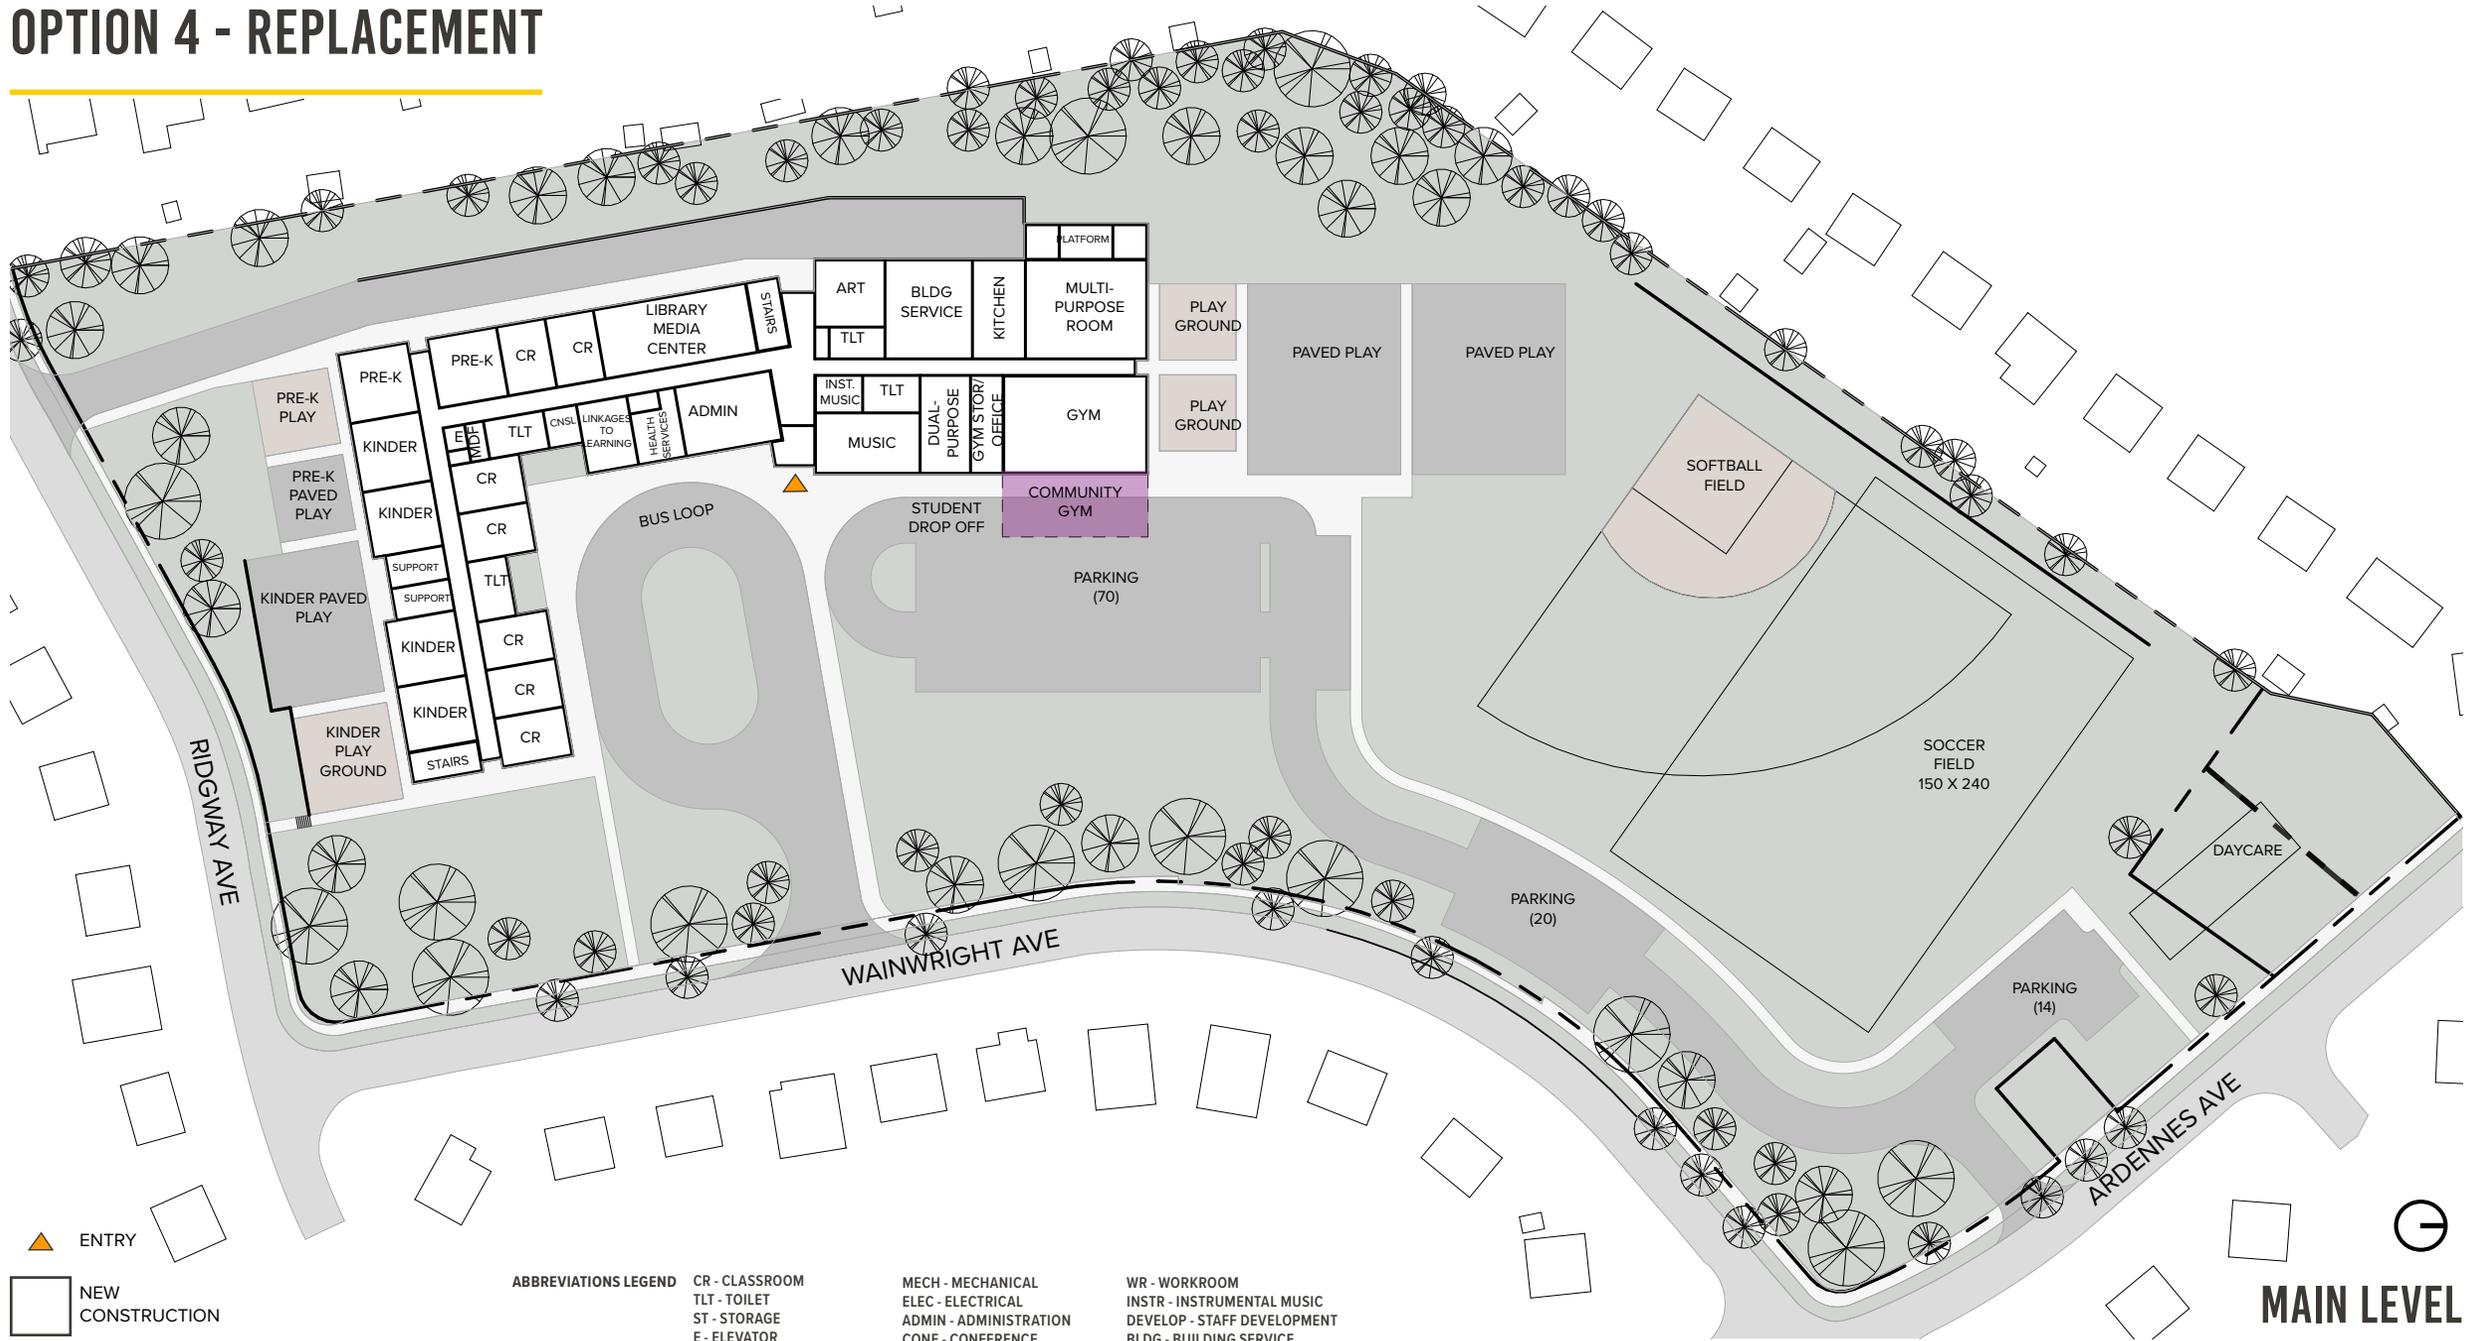
# OPTION 4 - REPLACEMENT

▲ ENTRY

□ NEW CONSTRUCTION

<p align="center"><b>Option 4 - Replacement</b></p>
SCOPE	<ul style="list-style-type: none"> <li>Existing building is demolished.</li> <li>New building and site program are provided.</li> <li>Relocate site program and circulation</li> </ul> <p>79,750 GSF - Demolition 80,588 GSF - Addition</p>
PROS	<ul style="list-style-type: none"> <li>All new construction</li> <li>Addresses accessibility issues</li> <li>Design meets ed spec requirements</li> </ul>
CONS	<ul style="list-style-type: none"> <li>High impact to the site = higher cost</li> <li>Community-sized gym is an add alternate</li> </ul>

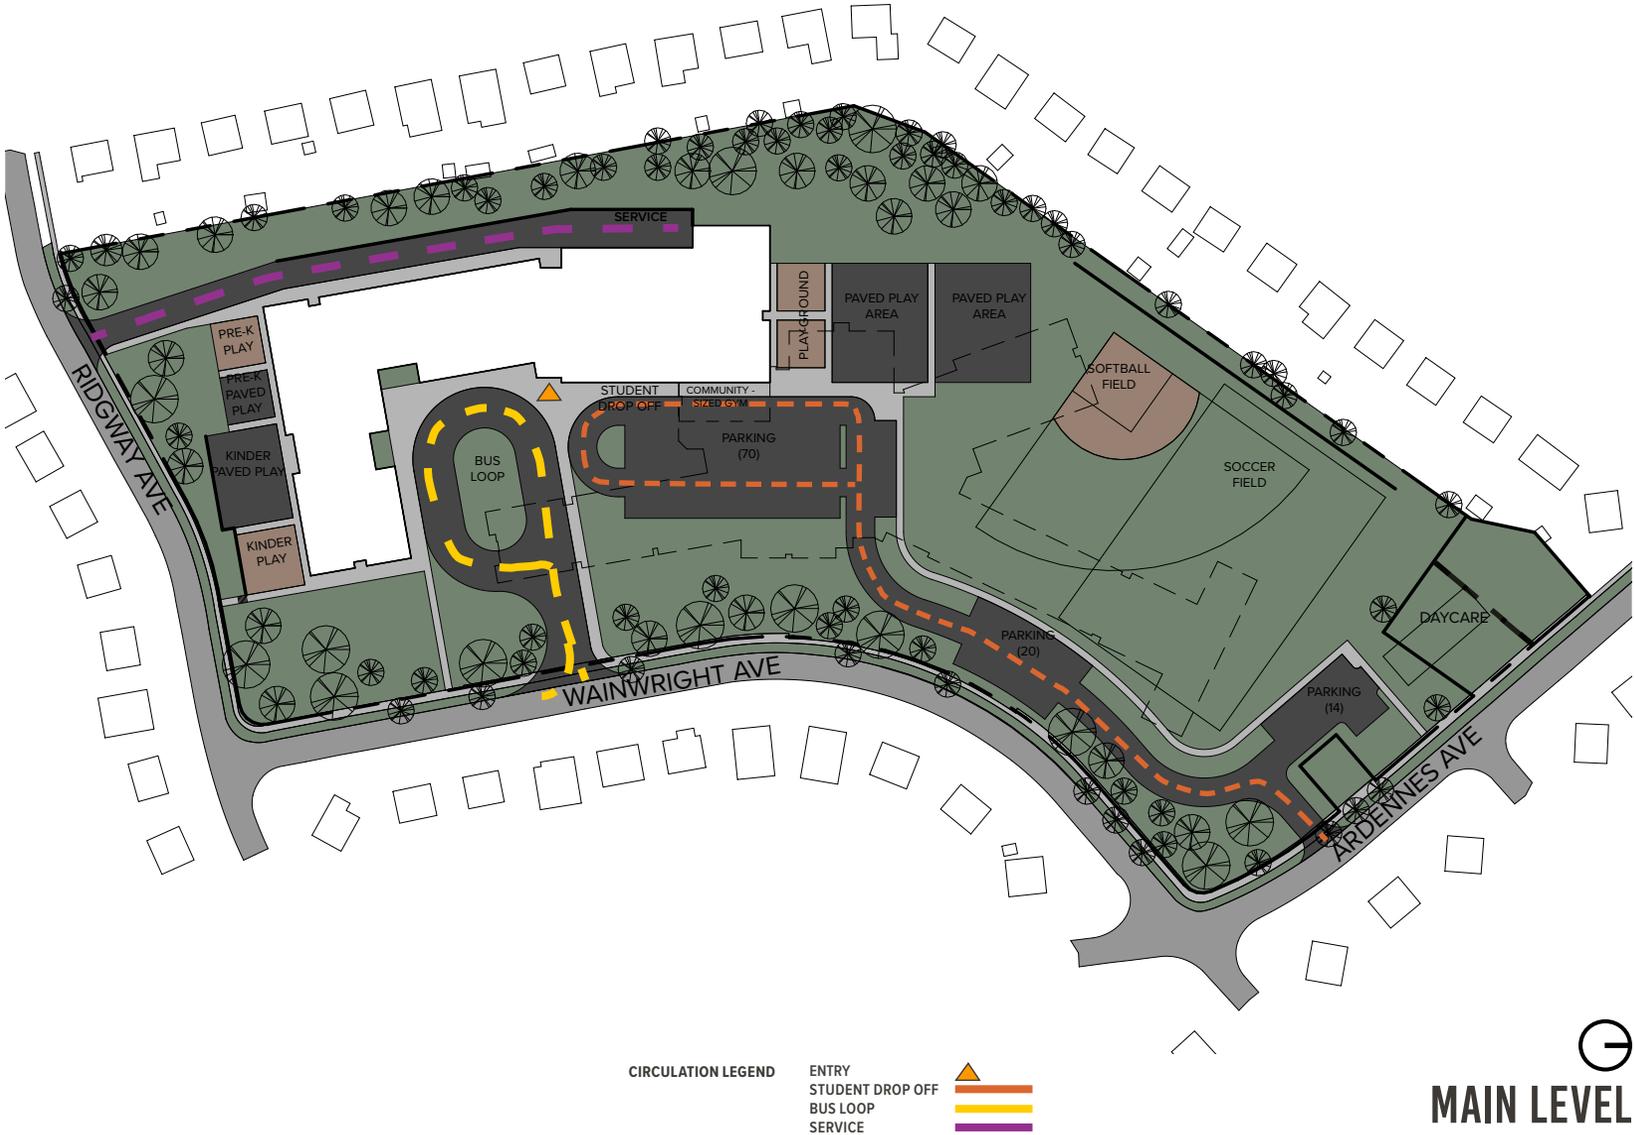
# SUMMARY

Options	Scope	Pros	Cons
<p style="text-align: center;">Option 1 - Renewal</p>	<ul style="list-style-type: none"> <li>• Existing parking and play areas remain unchanged</li> <li>• Electrical &amp; Plumbing system replacement</li> <li>• Renovate finishes</li> <li>• Upgrade existing restrooms to meet MCPS standards</li> <li>• Renovate existing building to meet accessibility standards.</li> <li>• Elevator added for lower level access</li> </ul> <p>70,932 GSF - Renewal 8,818 GSF - Renovation</p>	<ul style="list-style-type: none"> <li>• Sprinkler system added</li> <li>• Replaces outdated building systems</li> <li>• Addresses accessibility issues</li> <li>• Community-sized gym remains</li> </ul>	<ul style="list-style-type: none"> <li>• Does not provide the following program spaces: Dual-Purpose Room, Music, &amp; Instrumental Music</li> <li>• Administration, Health Services, 5 Classrooms, Multi-Purpose Room, &amp; Kitchen all undersized per ed spec.</li> <li>• Lockers in corridors cannot be accommodated</li> </ul>

<p style="text-align: center;">Option 2 - Less than 50% Demo</p>	<ul style="list-style-type: none"> <li>• Less than 50% of existing building would be demolished and additions would be added to meet program requirements.</li> <li>• This option is 1-story.</li> <li>• Electrical &amp; Plumbing system replacement</li> <li>• Renovate finishes</li> <li>• Upgrade existing restrooms to meet MCPS standards</li> <li>• Renovate existing building to meet accessibility standards.</li> </ul> <p>30,913 GSF - Demolition 36,645 GSF - Renewal 12,192 GSF - Renovation 30,052 GSF - Addition</p>	<ul style="list-style-type: none"> <li>• Sprinkler system added</li> <li>• Replaces outdated building systems</li> <li>• Addresses accessibility issues</li> <li>• Design meets ed spec</li> <li>• Community-sized gym remains</li> </ul>	<ul style="list-style-type: none"> <li>• Inefficiencies in existing building to address accessibility and new restroom layout</li> <li>• The required number of lockers in corridors cannot be accommodated.</li> </ul>

Options	Scope	Pros	Cons
<p style="text-align: center;">Option 3 - More than 50% Demo</p>	<ul style="list-style-type: none"> <li>• More than 50% of existing building is demolished.</li> <li>• Additions include a 2-story classroom wing and expanded kitchen and music suite on the SW corner of the building.</li> <li>• Electrical &amp; Plumbing system replacement</li> <li>• Renovate finishes</li> <li>• Upgrades to existing restrooms to meeting MCPS standards</li> <li>• Renovate existing building to meet accessibility standards.</li> </ul> <p>40,813 GSF - Demolition 29,021 GSF - Renewal 9,916 GSF - Renovation 42,483 GSF - Addition</p>	<ul style="list-style-type: none"> <li>• Sprinkler system added</li> <li>• Replaces outdated building systems</li> <li>• Addresses accessibility issues</li> <li>• Design meets ed spec</li> <li>• Community-sized gym remains</li> </ul>	<ul style="list-style-type: none"> <li>• Inefficiencies in existing building to address accessibility and new restroom layout</li> <li>• The required number of lockers in corridors cannot be accommodated.</li> </ul>

<p style="text-align: center;">Option 4 - Replacement</p>	<ul style="list-style-type: none"> <li>• Existing building is demolished.</li> <li>• New building and site program are provided.</li> <li>• Relocate site program and circulation</li> </ul> <p>79,750 GSF - Demo 80,588 GSF - New Construction</p>	<ul style="list-style-type: none"> <li>• All new construction</li> <li>• Addresses accessibility issues</li> <li>• Design meets ed spec requirements fully</li> </ul>	<ul style="list-style-type: none"> <li>• High impact to the site = higher cost</li> <li>• Community-sized gym is an add alternate</li> </ul>
